Raymond Fire & Rescue

Occupancy: Cafe Sebago Occupancy ID: Roosevelt 1248 Address: 1248 Roosevelt Trail RD Raymond ME 04071

Inspection Type: Annual Life Safety Inspection Date: 8/18/2021 By: Jones, Wayne (JONESW) Time In: 09:30 Time Out: 10:00 Authorized Date: 08/18/2021 By: Jones, Wayne (JONESW)

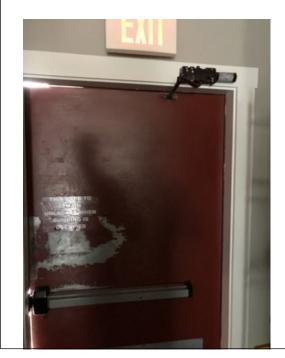
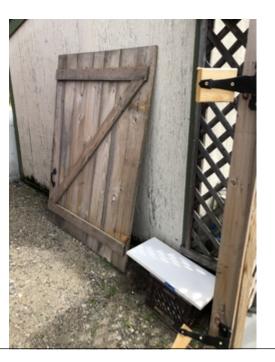
Notes: Rear Exit Door self-closer needs adjustment and replacement of self-closer unit cover. Outside patio exit door needs to be repaired and replaced.

Notes: 8-18-2021: Outside Patio area Exit Door has been re-attached and operates properly with less than 5 lbs. of force (see photos).

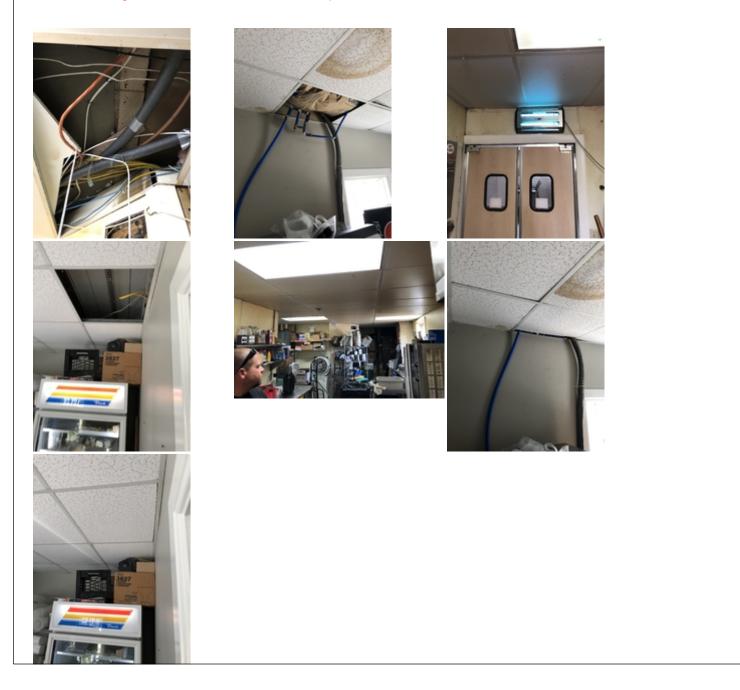
Notes: 8-10-2021: A number of ceiling tiles were not in place. These items were brought to the business owners attention.

8-18-2021: Ceiling tiles have been re-installed as required.

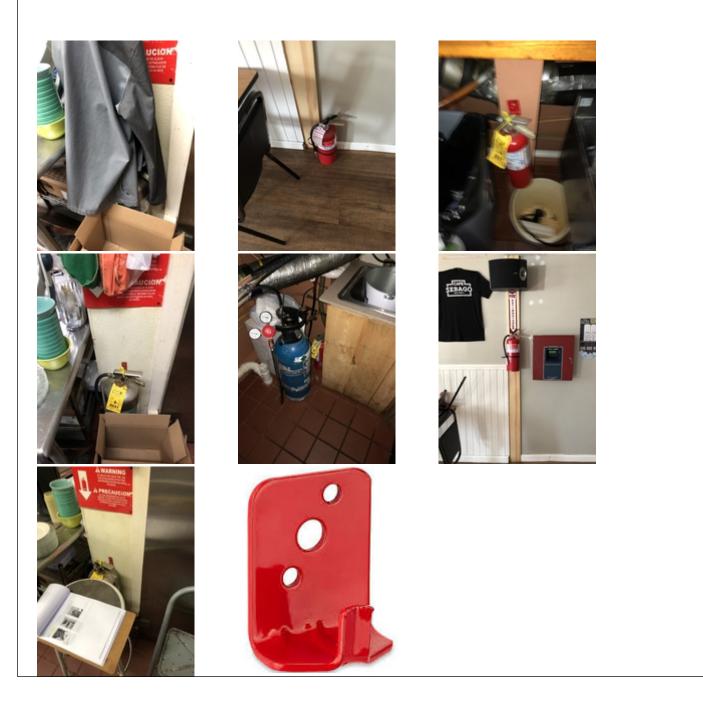
Notes: 8-10-2021: Extinguishers were found obstructed from view or needing to be mounted with signage. All extinguishers (except one) were inspected and tagged.

8-18-2021: Extinguishers mounted with signage as required (see the last 3 photos). New extinguisher in Dining Area will need to be Inspected, serviced and tagged for next years (2022) inspection. It should also be mounted with a mount designed for this purpose, as it has a temporary mounting hook until a replacement is obtained (see photo of an approved bracket).

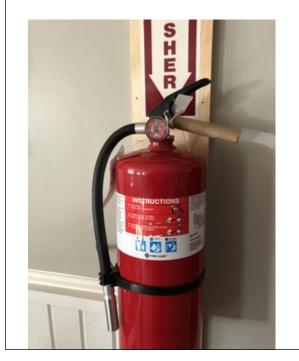
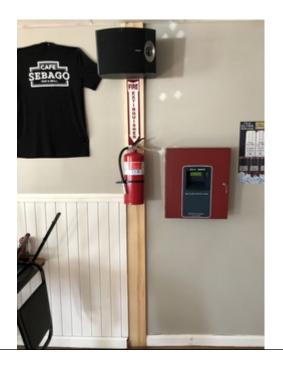
Notes: 8-10-2021: Three of the extinguishers seen in the photos above needs to be mounted with signage.

8-18-2021: See note above. Extinguisher located next to carbonation cylinder is not required and has been replaced by the new Dining Room area extinguisher noted above.

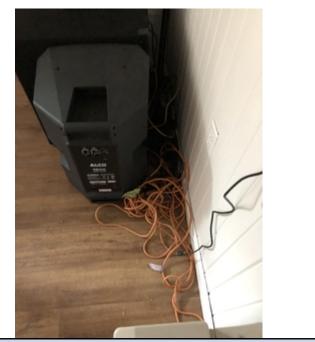
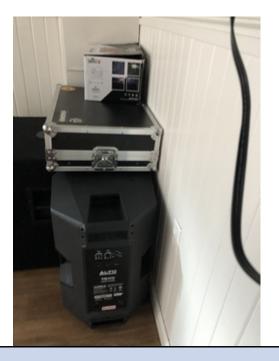
Notes: 8-10-2021: Extension cords were found in the area of the karaoke entertainment area. Business owner was made aware.

8-18-2021: Extension cords have been removed from the area containing the karaoke entertainment equipment.

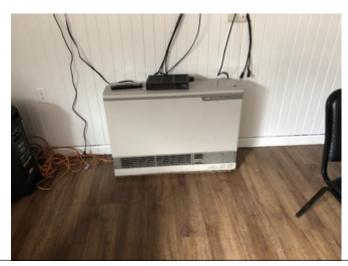
Notes: There is no guard to keep clients away from the LPG heater in dining/entertainment area.

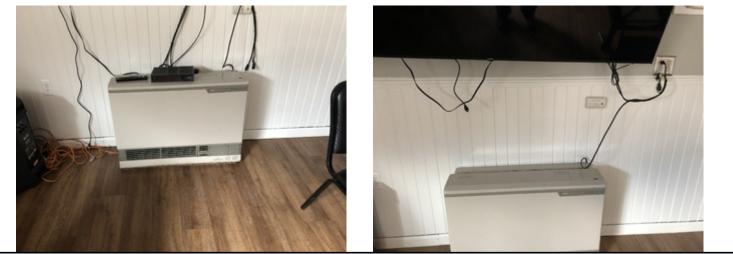
Notes: 8-10-2021: Electrical cords, electrical equipment and remote controls were found on top of the LPG heater. These items must not be stored on top of this heating unit.

8-18-2021: The electrical cords, electrical equipment and remote controls have been removed from this LPG heating unit. The business owner has been asked to attach the electric cord for this heater unit to the wall to prevent it from coming into contact with the top of the heater. Owner will send a follow-up photo.
