**Exhibit 9**  
**Site Condition Report**

## *Attachment 9. Site Condition Report*

**14265 – Jordan Bay Marina**

**December 18, 2019**

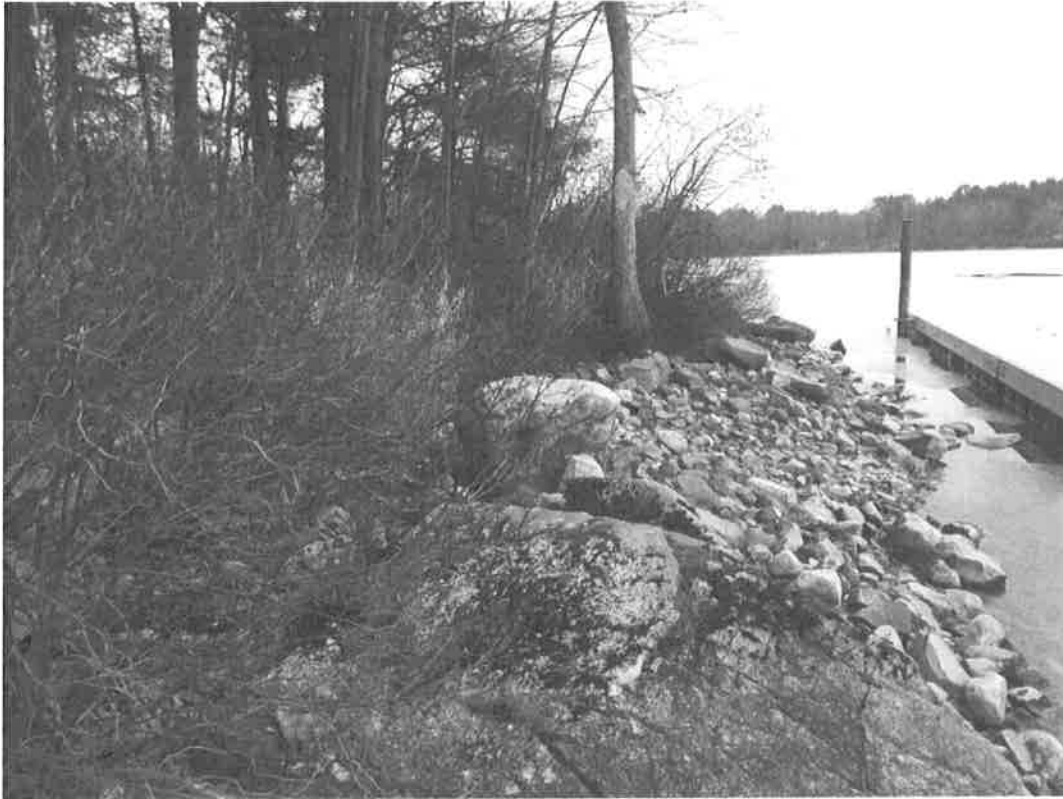
**Photo 1.** Shoreline bank of Sebago Lake adjacent to project area. 12/17/19 by Michael D. Jakubowski

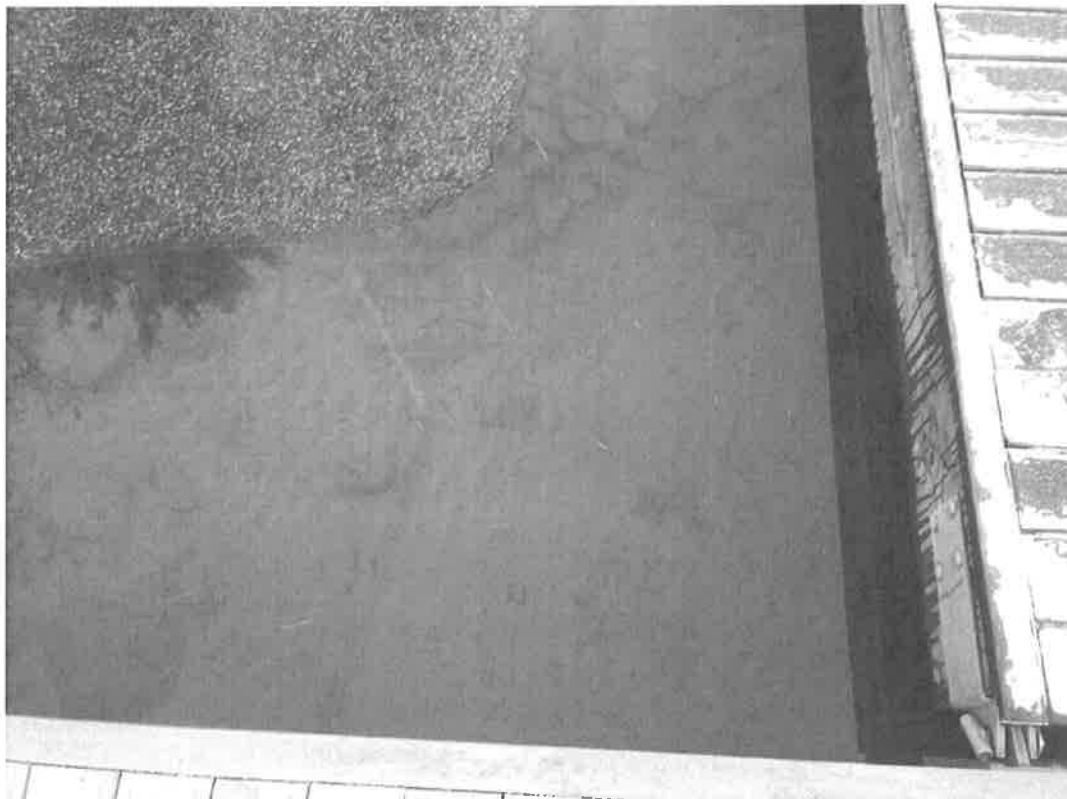
**Photo 2.** Typical fine sand substrate with cobbles found within project area. 12/17/19 by Michael D. Jakubowski

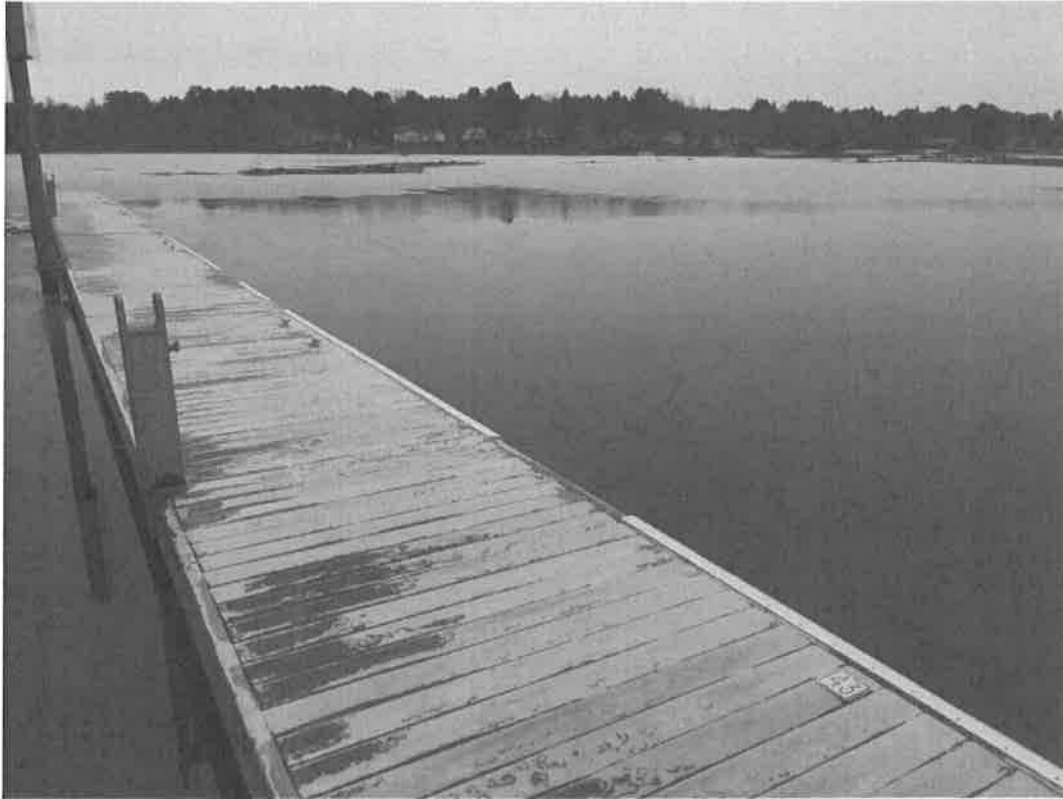
**Photo 3.** Area to be impacted with proposed dock expansion. 12/17/19 by Michael D. Jakubowski

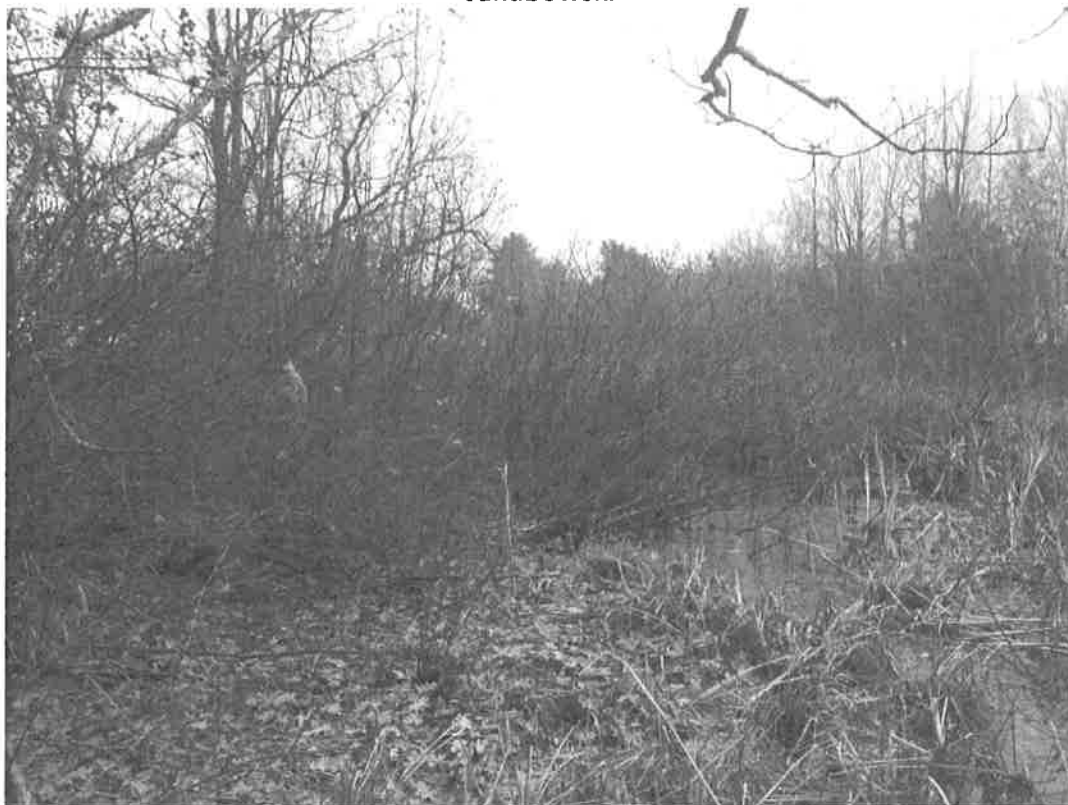
An emergent persistent seasonally flooded/saturated wetland (PEM1E) is found east of the impact area. It drains into Sebago Lake and is approximately 2 acres in size. This wetland is dominated by broadleaved cattail (*Typha latifolia*) and various carex species (*Carex spp.*).

**Photo 4.** PEM1E wetland east of the impact area. 12/17/19 by Michael D. Jakubowski
