*Panther Pond  
Conservation Project  
Phase I  
2005 - 2008*

*Working together to protect and improve  
the water quality of Panther Pond*

# Project Purpose

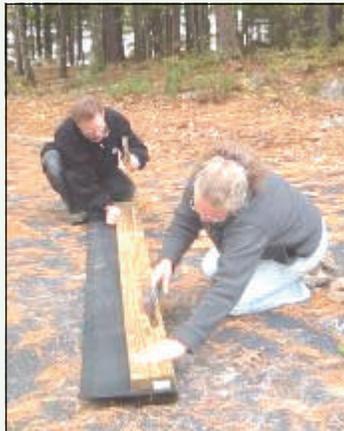
Volunteers participated in a workshop on Jordan Lane to improve a private boat launch on their road. The volunteers constructed two rubber runoff diverters (right) and installed them across the ROW (bottom).

Rubber diverters are used to direct water away from the lake into stable vegetated areas. Many of the techniques used to address erosion issues on right-of-ways can also be used on gravel driveways and seasonal gravel roads.

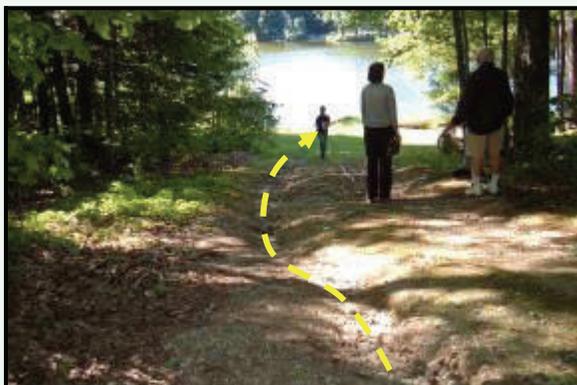
**Before: Runoff causes eroded gully that washes sediment directly into Panther Pond**

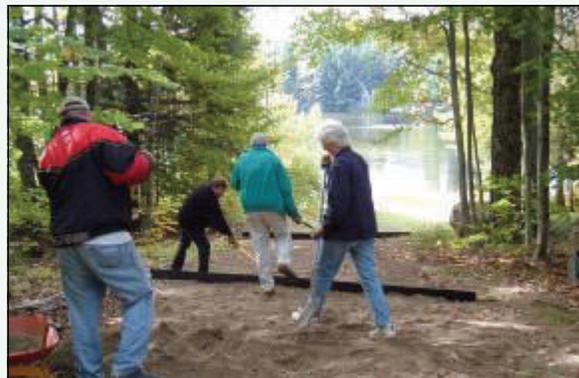
**After: Rubber diverters direct runoff into stable vegetated areas and away from the lake**

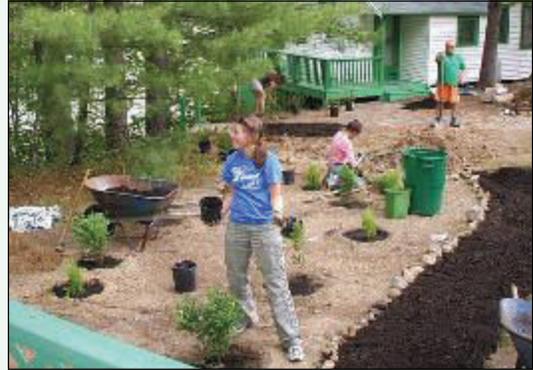
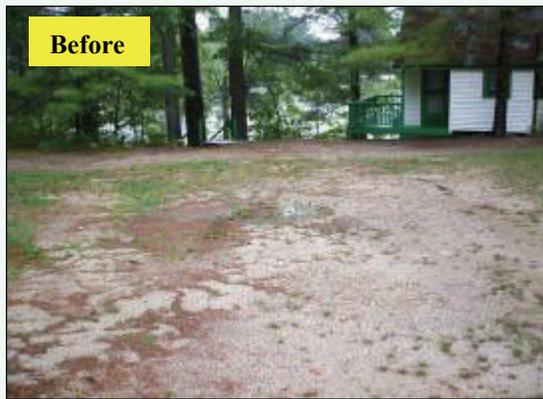
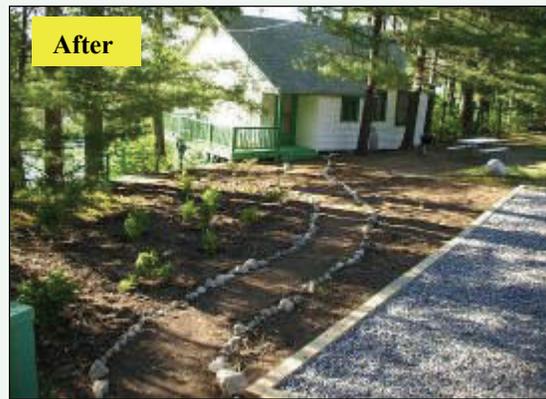
Twelve residents from the Panther Pond Watershed participated in a workshop at Plummerville to install a vegetated buffer and minimize the bare soil open area. The path was stabilized with erosion control mulch to reduce the sediment load to the lake. Crushed rock and timbers were used to define the parking area allowing for infiltration of water from the camp road. In addition, the road was graded to shed water away from the lake.

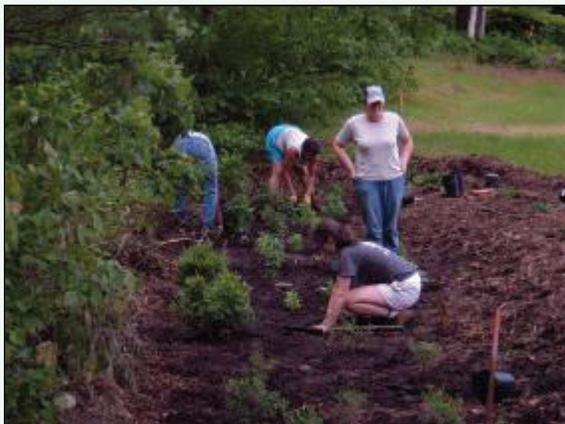
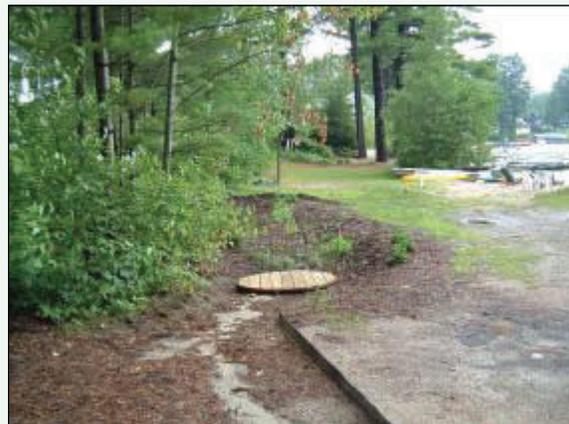
The landowner and volunteers attend a conservation landscaping workshop to install a rubber diverter and rain garden to collect stormwater runoff from the Plummerville boat launch. In addition, infiltration steps were installed on two camp paths.

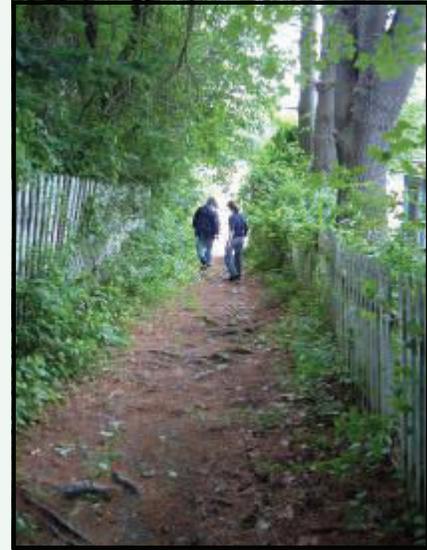
*Noralee Raymond, RWPA and Wendy Garland, DEP, discuss how to repair the Maple Avenue ROW*

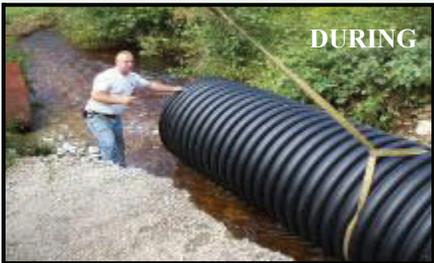
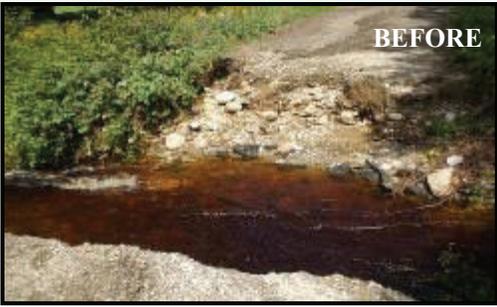
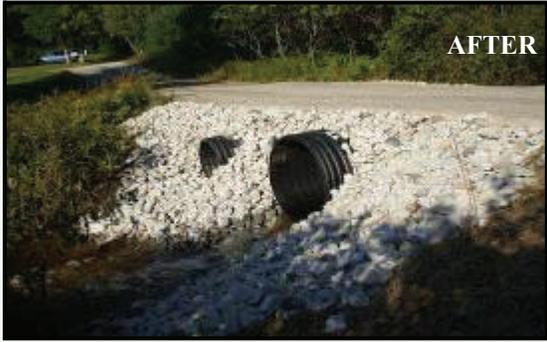
Several upstream culverts on the state road were increased in size rendering the size of the 36" private road culvert too small for the increase in stream flow. The culvert was washed downstream during an August 2008 rain storm (5" storm) washing 63 yards of gravel into Hayden Brook which outlets into Panther Pond. The Town of Raymond Public Works Department increased the culvert size to 48" and installed an overflow culvert to accommodate larger storms.

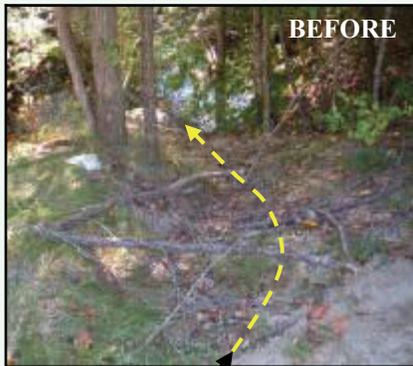
This site was identified as a high impact site in the watershed survey. Stormwater runoff caused severe road shoulder erosion and created a large eroded gully above the stream culvert. Direct flow of sediment traveled into a stream that feeds Panther Pond. Redefined and vegetated ~120 of road shoulder and ditching, installed two turnouts in ditch to direct water into vegetation, stabilized bank above culvert outlet with stone rip rap. This project was cost-shared with the Town of Raymond.

**Before: Severe erosion. Large eroded gully above culvert outlet.**

**After: Bank above culvert stabilized with stone rip rap.**

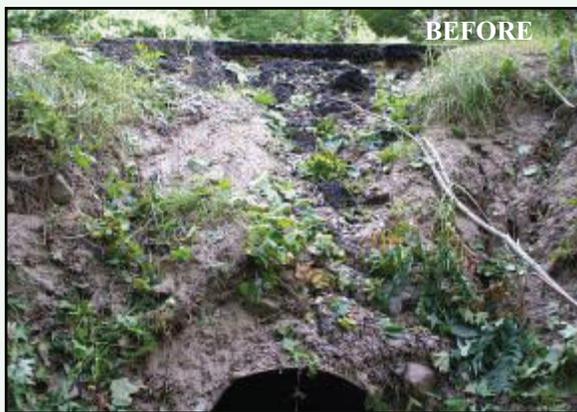
This site was identified as a high impact site in the watershed survey. Stormwater runoff traveled down the steep bank and caused severe erosion with direct flow of sediment to a stream that feeds Panther Pond. A culvert extension was added to the existing culvert, a proper slope was established, and the banks were properly stabilized with Geotextile fabric and stone rip rap. This project was cost-shared with the Town of Raymond.

**Before: Severe bank erosion**

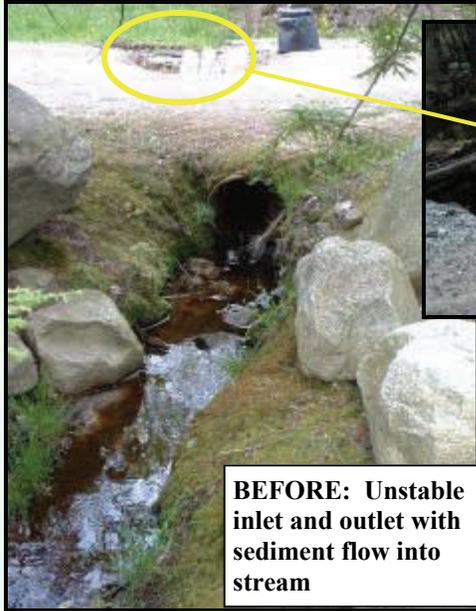
This site had a rusted out metal culvert with an unstable and eroding inlet and outlet and direct flow of sediment into the stream. Additionally it was undersized and washed out during the Patriot's Day storm. The Town of Raymond assisted with material delivery and a contractor replaced the culvert with a smooth bore polymer culvert to increase the flow capacity and stabilized the inlet and outlet with crushed stone. Work at these sites was cost-shared with the Lakeside Drive 63A Association.

**BEFORE:** Unstable inlet and outlet with sediment flow into stream

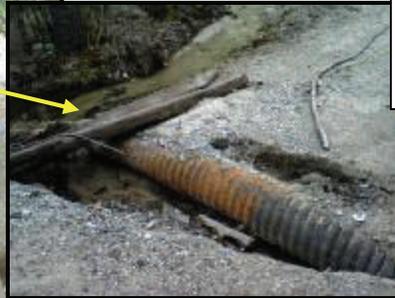
**BEFORE:** undersized, eroded culvert washed out in the Patriot's Day storm

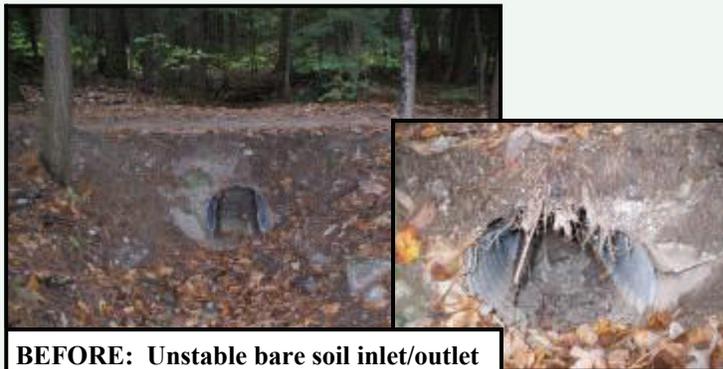
Erosion problems on this road included two rusted out metal culverts with unstable inlet and outlets and direct flow of sediment to springs that feed Panther Pond. The Town of Raymond assisted with material deliver and a contractor installed two polymer culverts, stabilizing the inlets and outlets with rip rap stone. Work at these sites was cost-shared with the River Road Association.

**BEFORE:** Unstable bare soil inlet/outlet

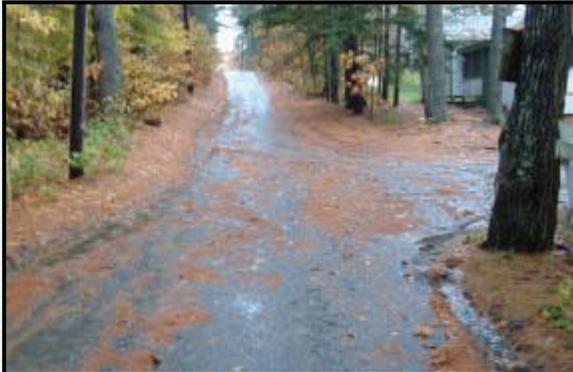
The Town-owned portion of David Plummer Road was a significant source of stormwater contributing runoff to **five medium impact and one high impact sites**. This steep, narrow, paved road with dirt shoulders did not have any stormwater management controls. Runoff washes directly from this road causing severe to moderate erosion on the road shoulders, private gravel road, two gravel driveways, several camp paths, boat launch and beach. The road was re-surfaced to allow for the installation of curbing to direct runoff to two catch basins which flow into a settling basin. This significantly reduced the volume of runoff to the private gravel road, paths and the lake. In addition to the federal grant, this project was funded by Maine DEP Stormwater Compensation Funds and cost-shared with the Town of Raymond.

**Before: Runoff erodes shoulder and private road with direct flow down eroded paths into the lake**

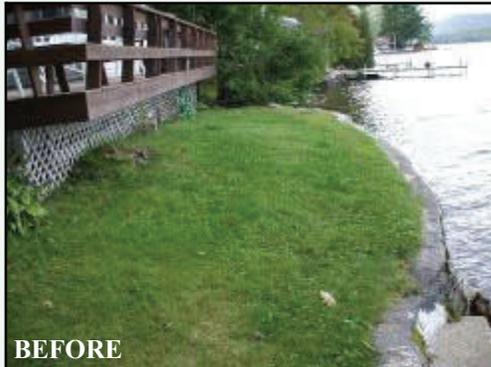
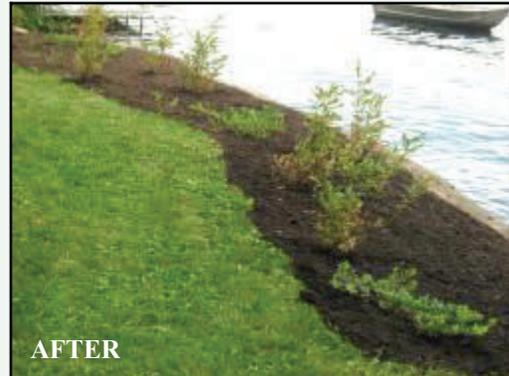
The natural vegetated buffer on this shorefront property had been completely removed. Native vegetation and erosion control mulch were installed along the shoreline. This buffer strip will be able to more effectively slow the running stormwater, which will give it time to infiltrate into the ground preventing nutrient filled runoff from reaching the lake.

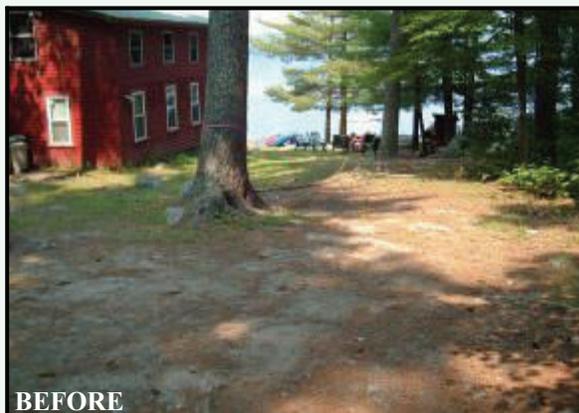
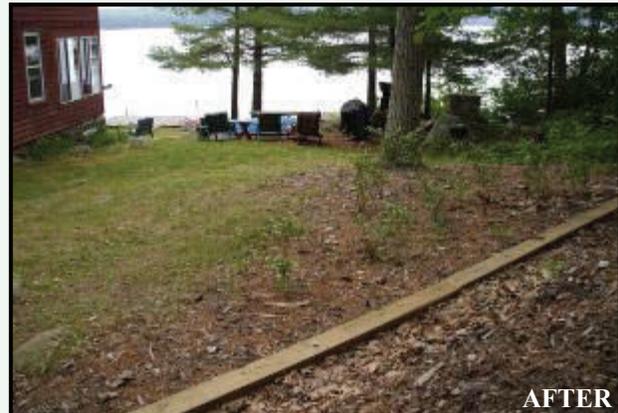
The Crilly family on Meadow Road installed a waterbar and upland vegetated buffer at the bottom of the driveway to filter runoff. Runoff from driveway washed across lawn, bare soil sitting area and path directly into Panther Pond. In addition to the upland buffer, the path and sitting area were covered with erosion control mulch and the plants added to their shoreline buffer.

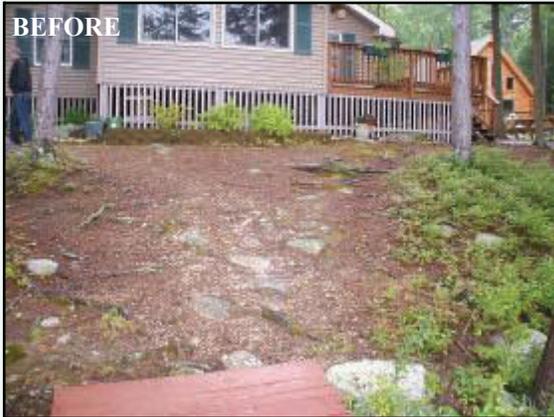
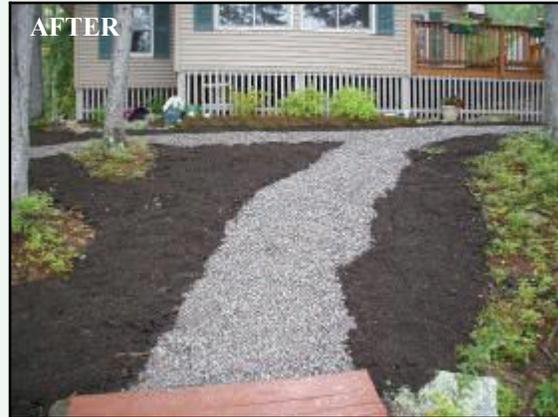
A group of volunteers came together to assist the Snells of Sloan's Cove Road with fixing their eroded path to the lake. The path was covered with 3" of crushed rock and erosion control mulch was spread over bare soil on the path sides. Crushed rock and erosion control mulch prevent erosion, protect underlying soil and help slow down and infiltrate runoff.

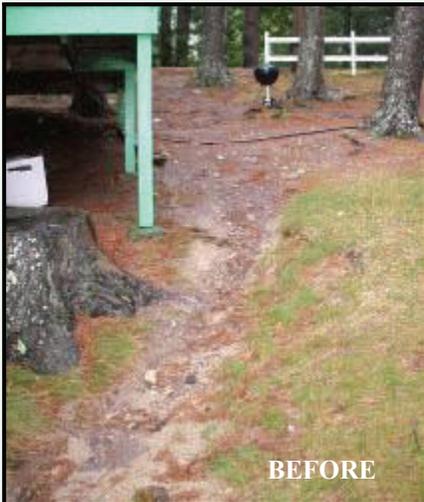
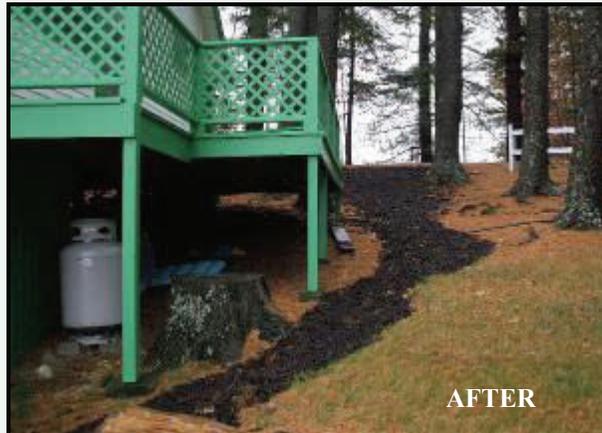
*Road runoff caused severe erosion on the Allen's path. The path was stabilized with 4" of Erosion Control mulch.*

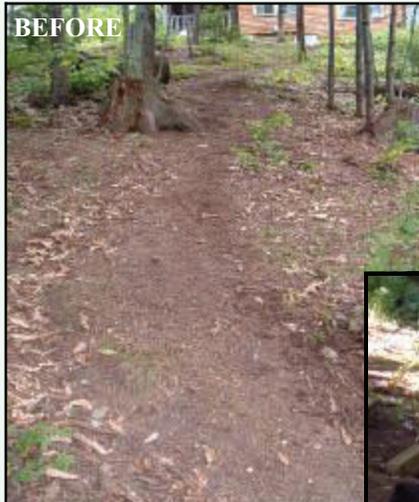
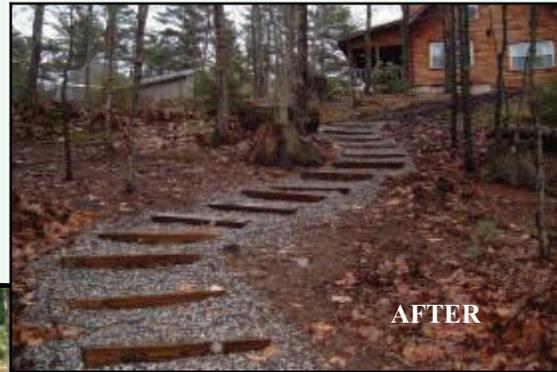
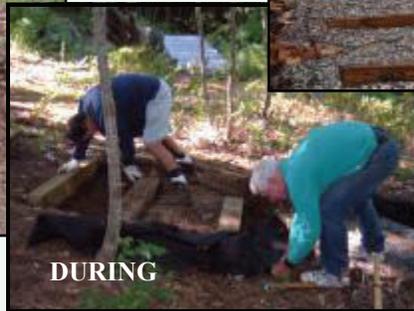
Infiltration steps are steps built with timbers and backfilled with crushed stone or pea stone to help water soak into the ground. Infiltration steps are designed to infiltrate runoff, stabilize soil, and provide safe footing on slopes.

*Ben Severn assists the Schramkos of Conifer Cove Road with installing infiltration steps on their steep eroded path to the lake.*

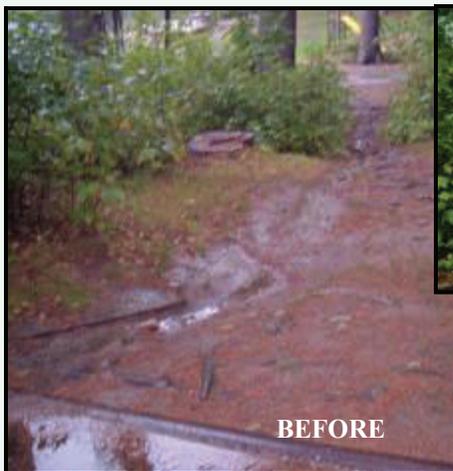
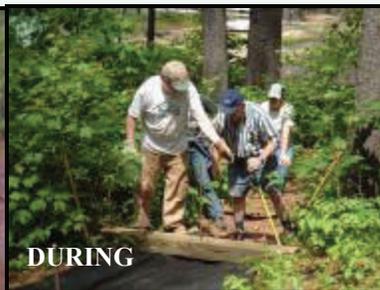
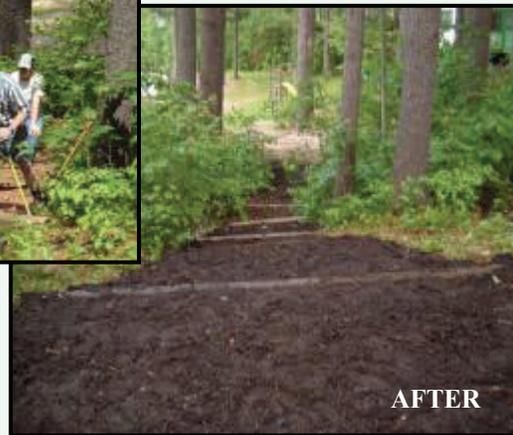
Waterbars are timbers placed lengthwise into the ground and are stabilized with erosion control mulch or stone to help stabilize slopes. The timbers and stabilizing material help to hold soil in place. This works to stop erosion by diverting water and not allowing it to concentrate in one area to create an eroded gully.

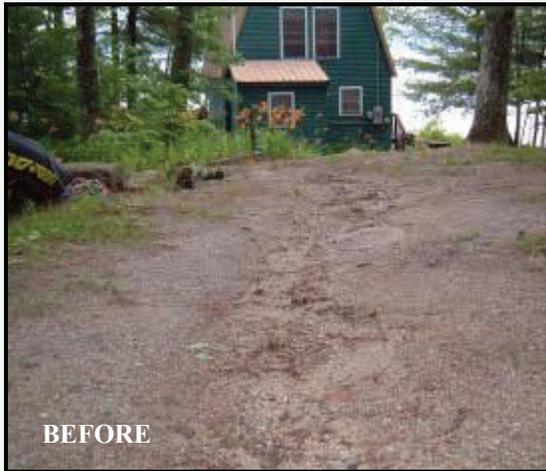
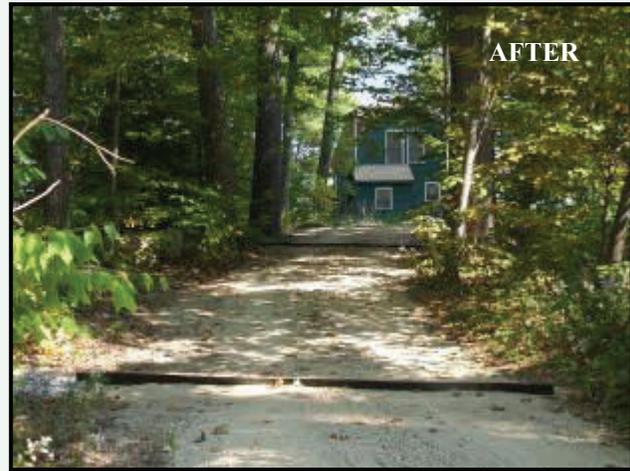
(Above) The Crillys of Meadow Road added hard packing material to the driveway surface to establish a crown. Three rubber diverters were installed to divert water off the driveway and into stable vegetated areas. (Below) Noralee Raymond and Ben Severn assist the Haydens of Meadow Road with installing a rubber diverter to prevent water coming from route 121 from washing down the driveway toward the lake.
