PANTHER POND CONSERVATION PROJECT PHASE II 2009 – 2012

*Working to protect and improve the
water quality of Panther Pond*

Report Prepared by Patrick Marass, FB Environmental Associates

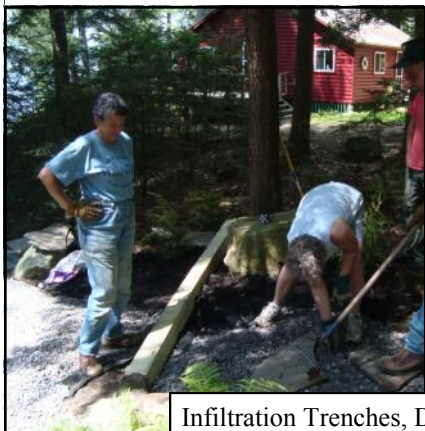
Infiltration Trenches, Dry-Wells, Water Diverters

These workshops provided an opportunity for local residents and volunteers to learn where and how to install BMPs, such as infiltration trenches, vegetative buffers, drywells, and water diverters. Over the course of the project, 9 workshops were organized and completed.

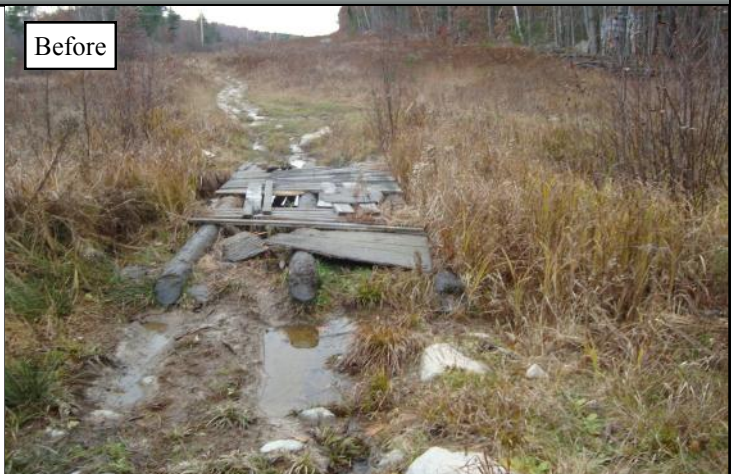
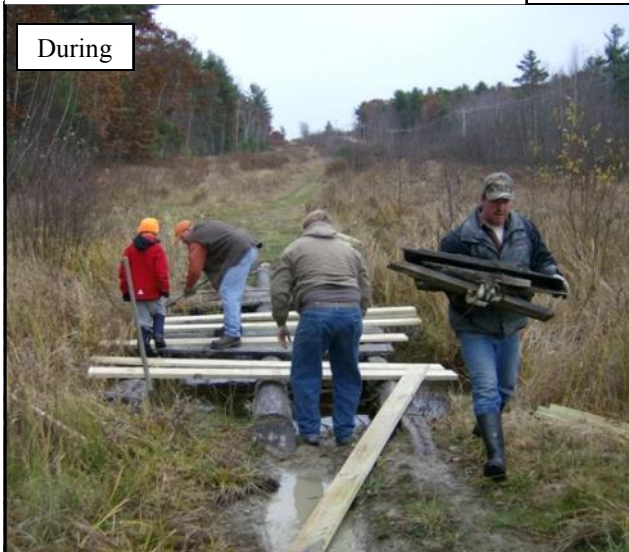
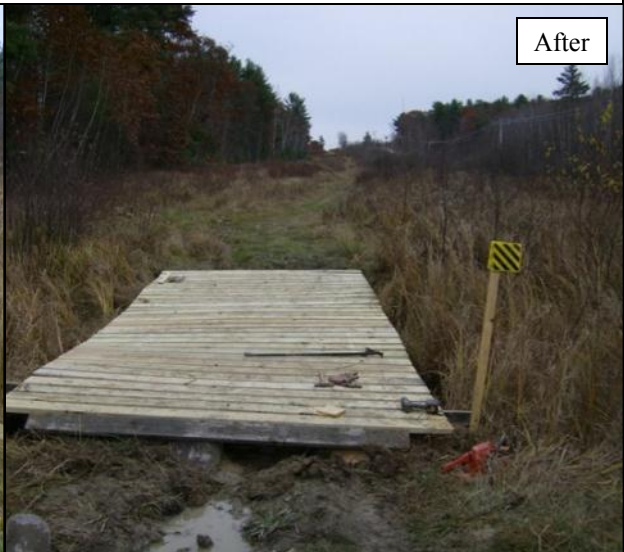
ATV - Site 2 Photos

Before photo (above) shows the broken ATV / Snowmobile bridge on a tributary stream to Panther Pond. Before the project, ATVs would cross through the stream to avoid the bridge. This would cause severe bank and stream bed erosion, sending sediments and phosphorus downstream and into Panther Pond. The photos below show volunteers rebuilding the bridge (left) and then the completed bridge (right). Now, ATVs and snowmobiles use this bridge, reducing pollutant loads to Panther Pond.

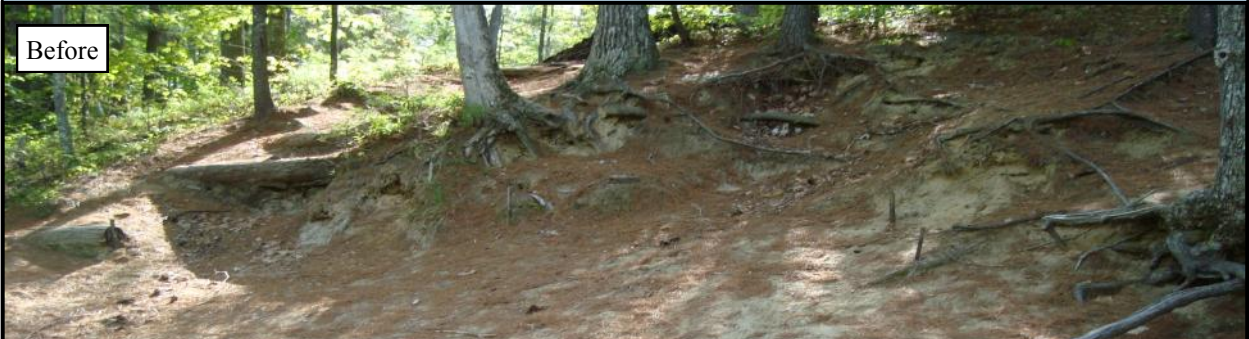
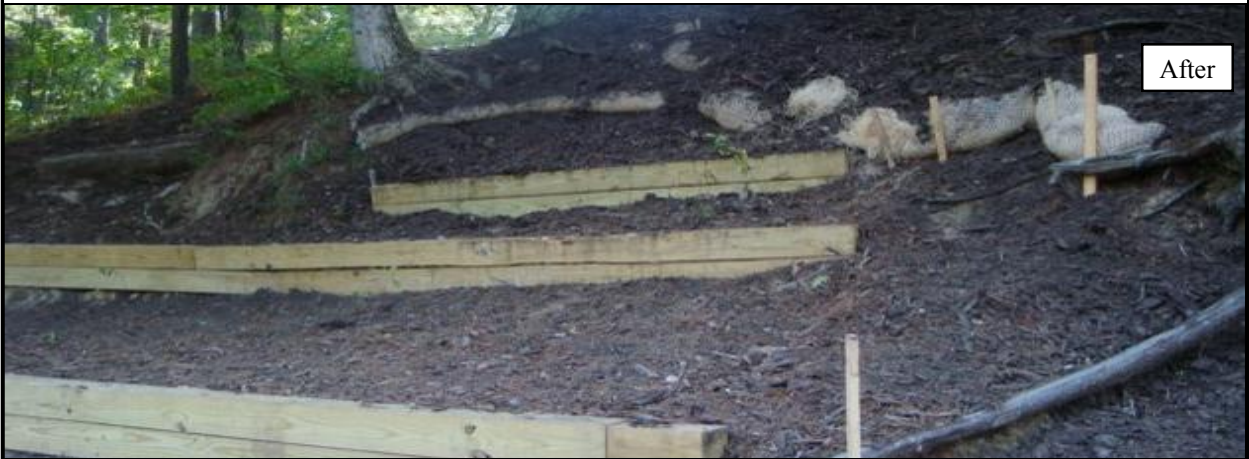
Camp Hinds - Site 1 Photos

Before photo (above) shows the bare and eroding soil located along an embankment of the Tenny River, the major tributary to Panther Pond. The After photo (below) displays the large timber waterbars, fiber rolls, erosion control mulch, and 288 seedlings installed on the banking to prevent erosion and stabilize the undercut bank.

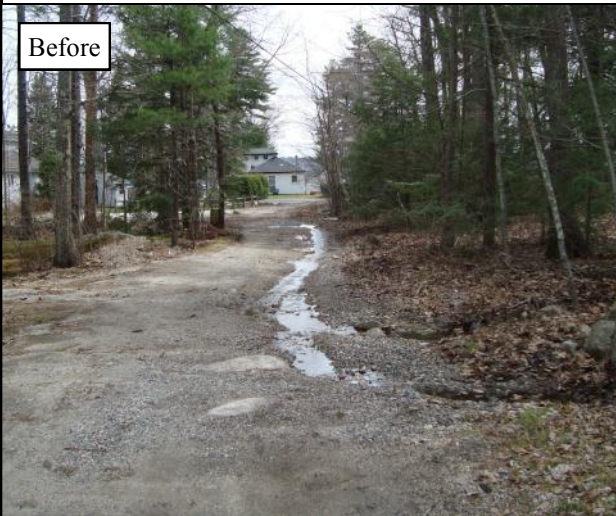
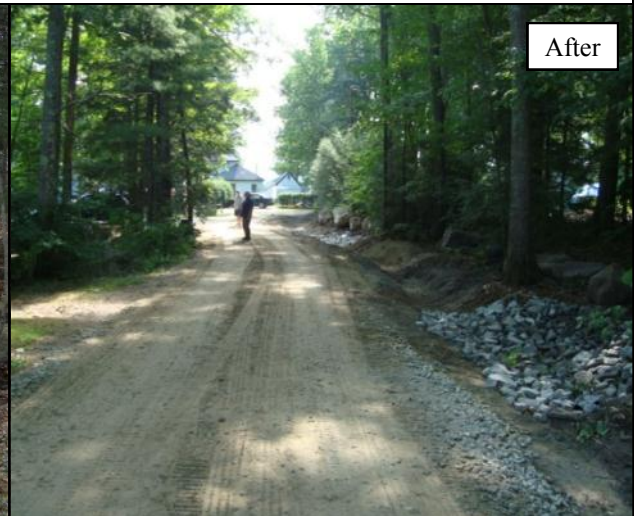
Lakeside Drive - Site 1 Photos

Before photo (below left) shows severe erosion along the road where there was no ditching and a crushed culvert. Large storms would wash out road material and deposit sediment into a nearby tributary to Panther Pond. The After photo (below right) displays how the road was reshaped, ditching and turnouts were installed, and the plunge pool was enlarged to reduce erosion.

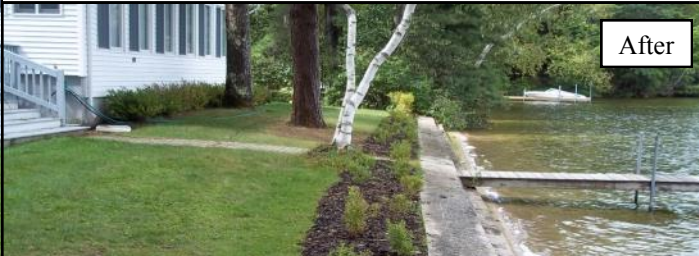
This property on South Shore Road had a grassed lawn extending to the waterfront (above). Over 50 blueberry plants were planted along with ECM (below) to create a vegetative buffer that infiltrates and filters runoff.

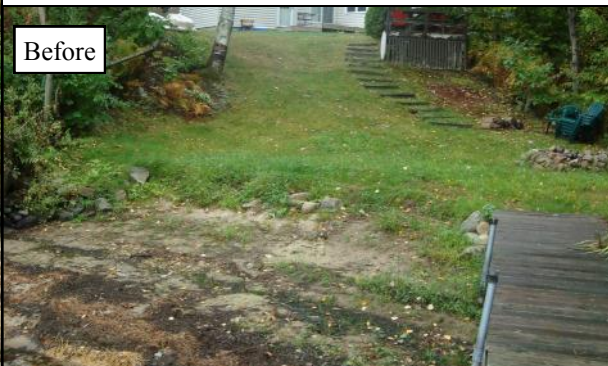
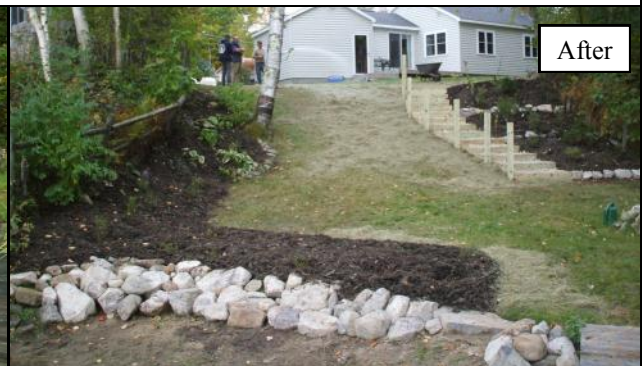
This property off Boulder Road had an unstable path and short grass down to the lake (below left). Water would carry down the steps and lawn and erode the beach area. Sturdy infiltrations steps and plantings along the bank were installed to slow down and capture runoff. The area above the beach was then built up and ECM, plantings, and boulders helped to capture and filter the runoff so it would no longer erode the beach area (below right).

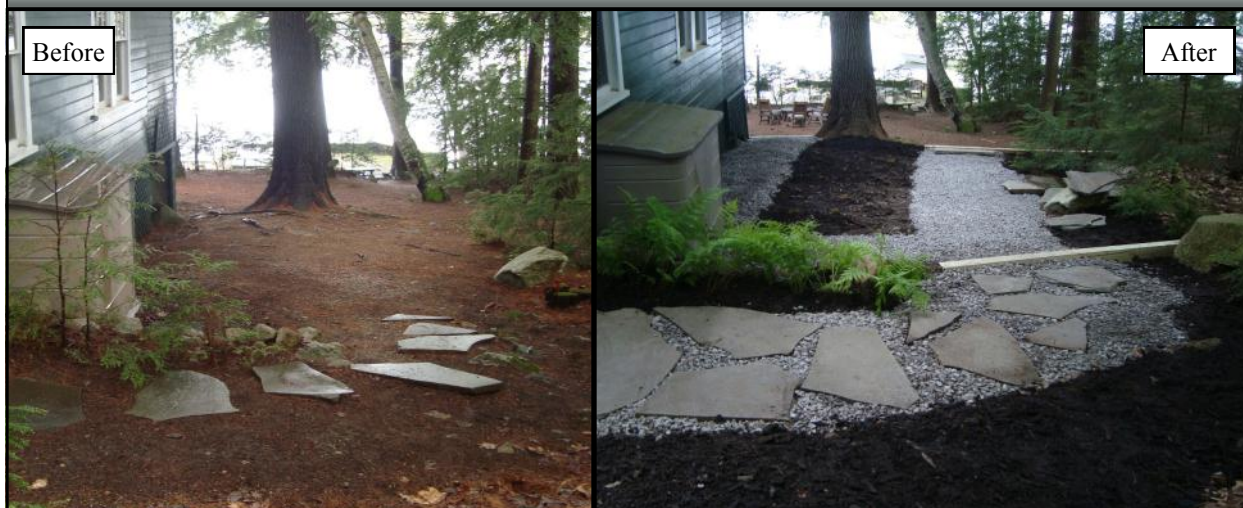
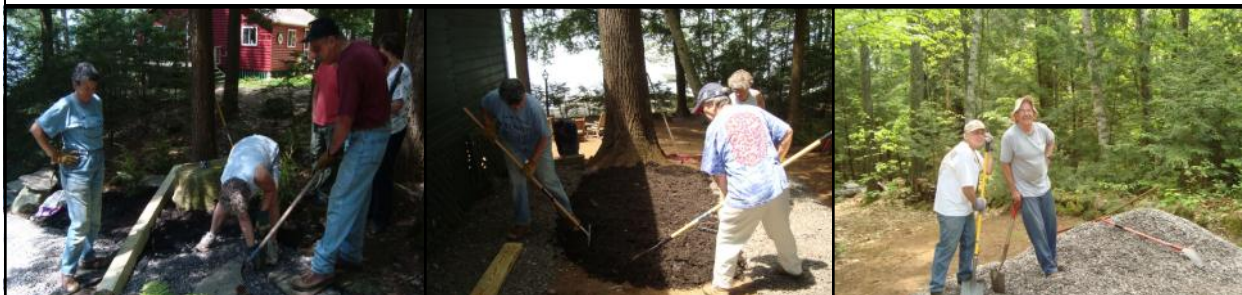
This property off Sloans Cove Road had a bare sloped path leading around the camp down to Panther Pond (above left). Over the course of two days, the landowners and many volunteers (below) installed infiltration trenches, waterbars, crushed stone, plantings, and ECM to stabilize the soil and create a defined path toward the lake (above right). As the photos show, conservation landscaping can be beautiful and fun!

Photos of the landowners and volunteers installing the conservation practices described above.
