PANTHER POND – STORMWATER MITIGATION PROJECT

Grantee Name Town of Raymond Project ID CP06009

Town of Raymond	Project: Stormwater Mitigation Fund Grant Project	Page No. 1
Raymond Waterways Protective Association	Subject: David Plummer Rd and Allen Rental Camps	Date: 10/10/05
		By: Noralee Raymond, RWPA

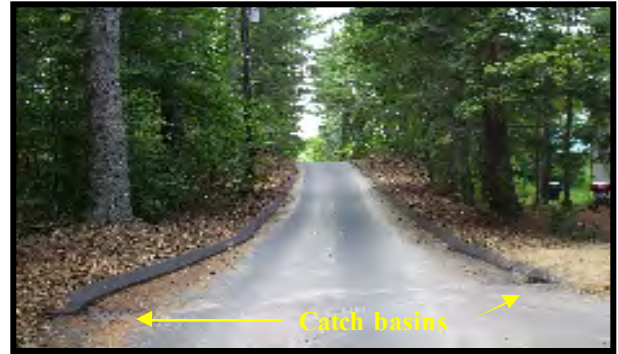
①

AFTER – paved road, installed two catch basins and directed runoff to settling basin

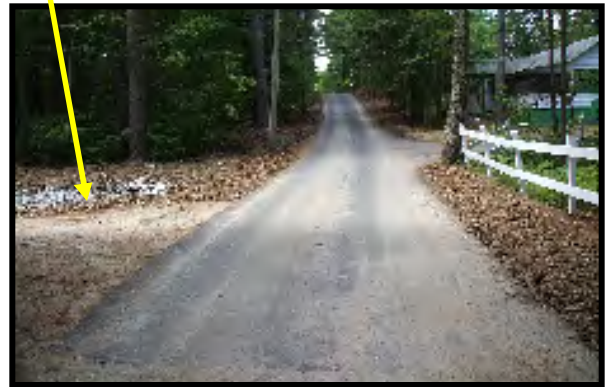
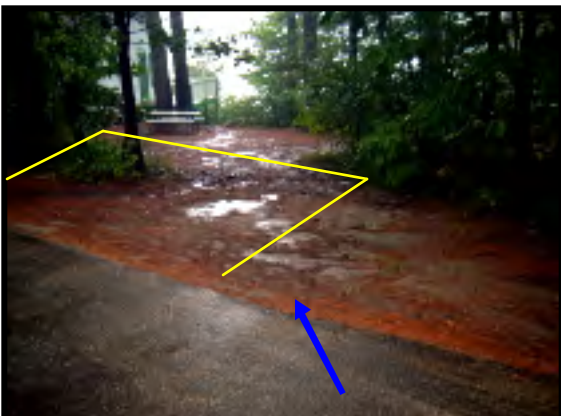
Driveway # 1

Runoff from road causes driveway erosion → Discontinue driveway, install crushed rock parking

BEFORE: Stormwater from the road causes driveway erosion and path erosion (see path #1 & #2 on page 10)

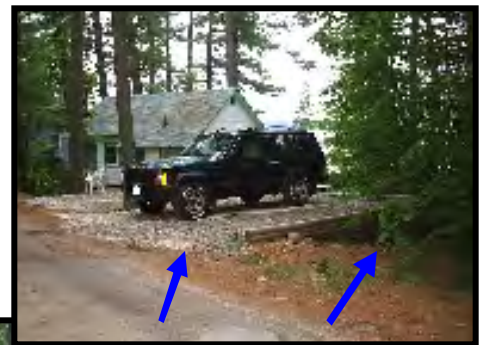
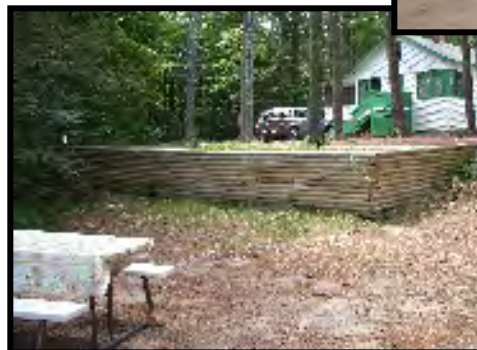
AFTER: Raised, crushed rock parking area installed. Runoff diverted into adjacent vegetation next to parking area and into crushed rock

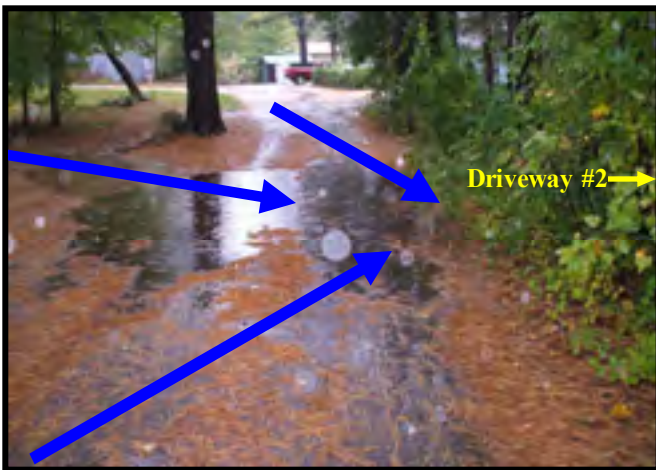
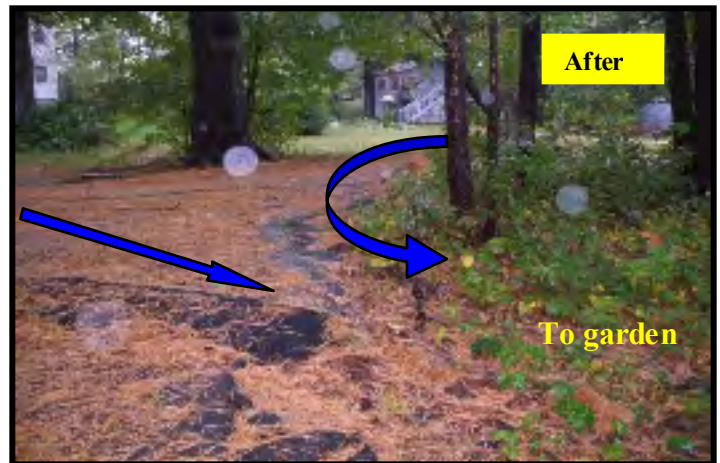
Driveway # 2

Stormwater from road and paved driveway erodes dirt driveway and paths → Install paved diverter and rain garden to capture road and driveway runoff, stabilize path at driveway edge

Stormwater runoff comes from 3 directions (road & bank) puddles and heads toward driveway

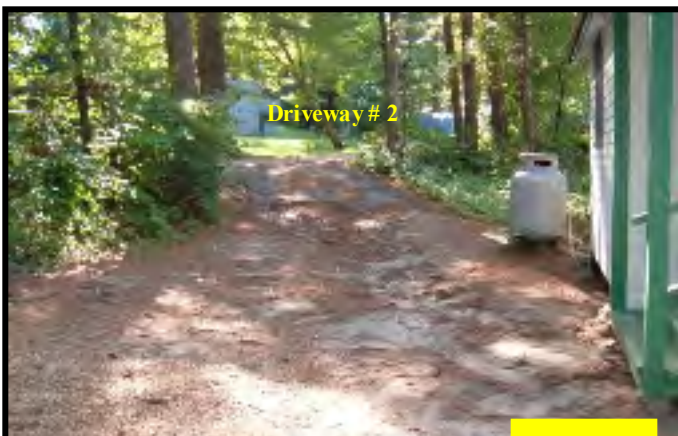
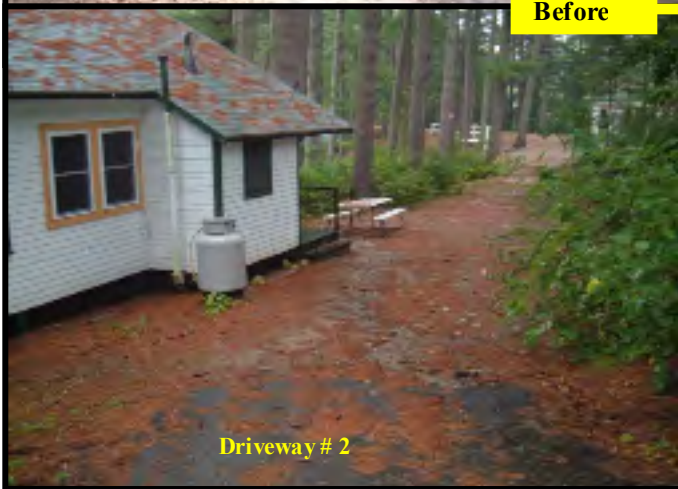
BEFORE: Runoff from paved road & driveway erodes end of paved driveway & camp paths

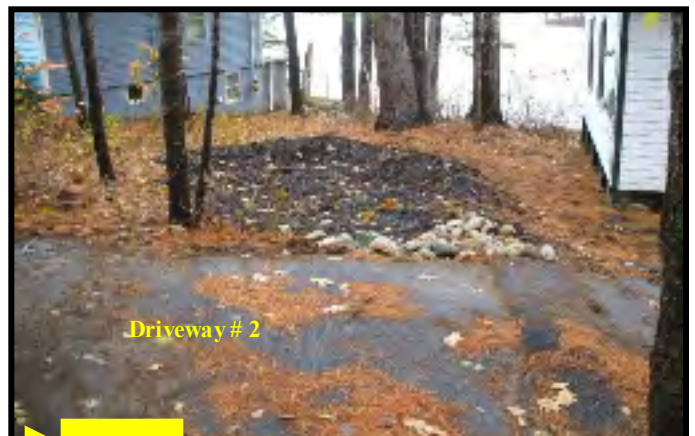
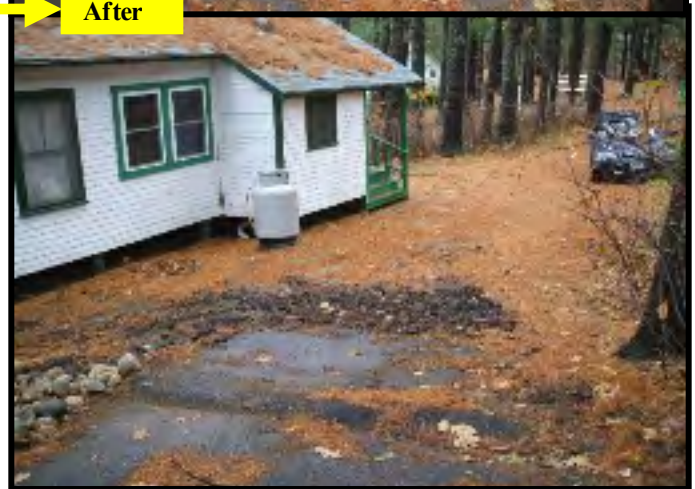
AFTER: Paved diverter directs water to rain garden. EC mulch at edge of driveway

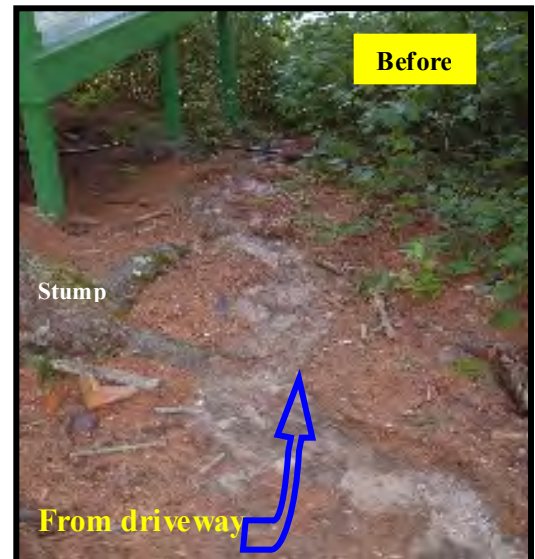
Path 1

BEFORE (above): Road and driveway runoff causes severe erosion on camp path to lake
AFTER (below): Infiltration steps and EC mulch on path. Rock trench directed toward vegetation (right bottom photo) added at top of path to receive additional runoff

Install Infiltration Steps and Erosion Control Mulch on Camp Paths 1 & 2

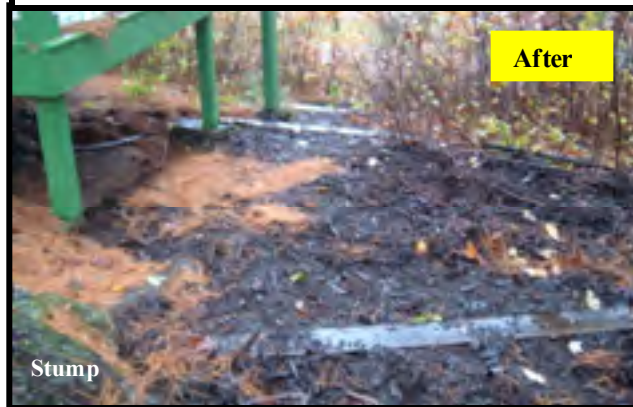
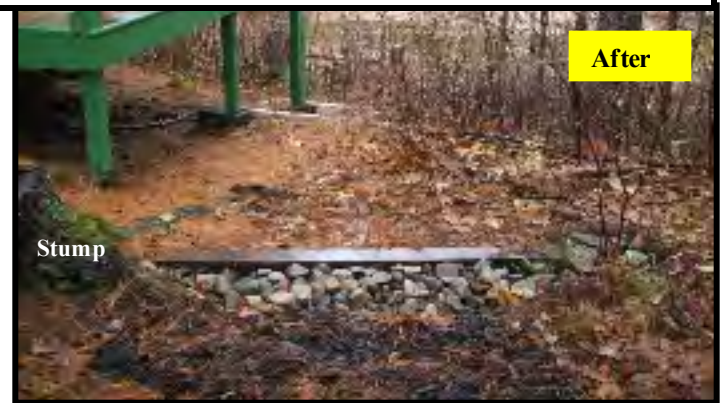
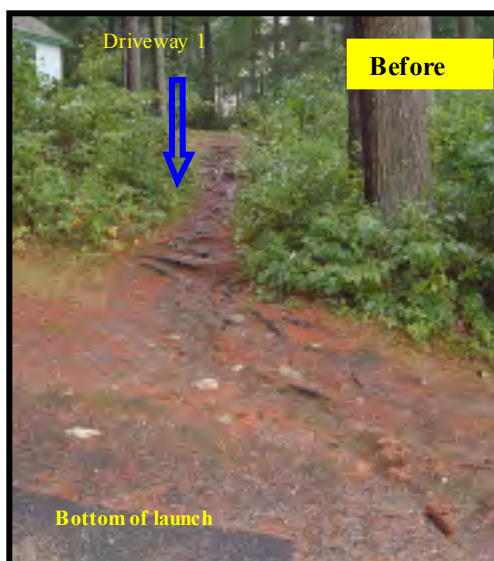
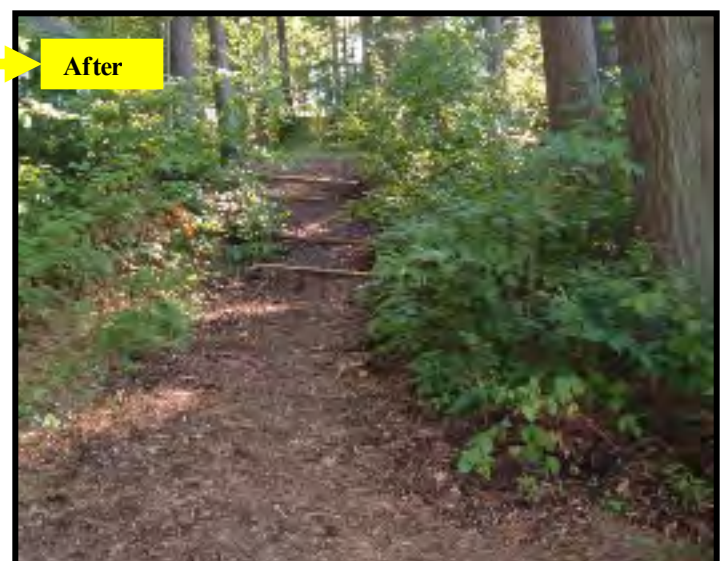
Path 2

BEFORE: Upland runoff erodes camp path, continues toward lake, eroding beach
AFTER: Infiltration steps & EC mulch stabilize path, runoff directed to rain garden (next page)

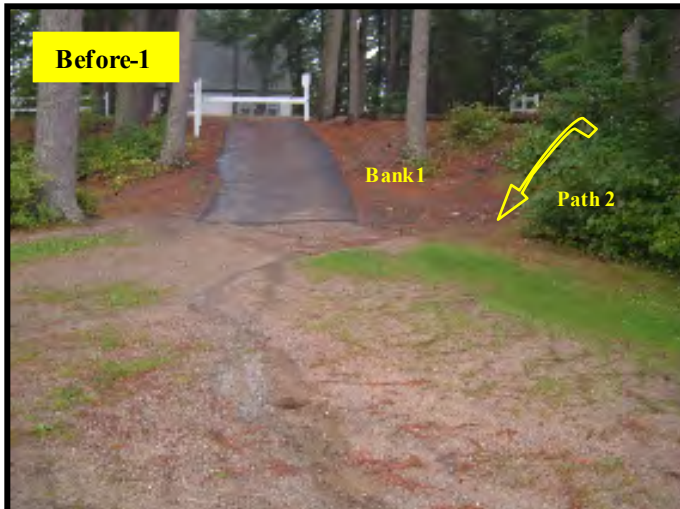
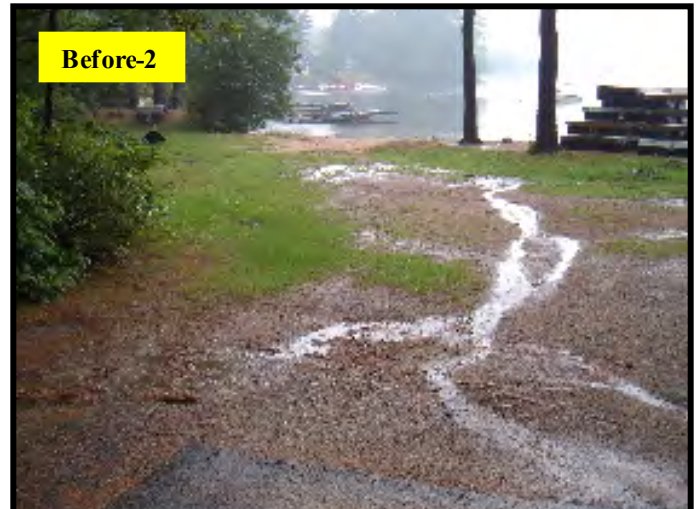
BEFORE: Stormwater runoff from camp road and boat access cause erosion on open area and beach

Rubber Diverter Directs Camp Road and Boat Access Stormwater into Rain Garden

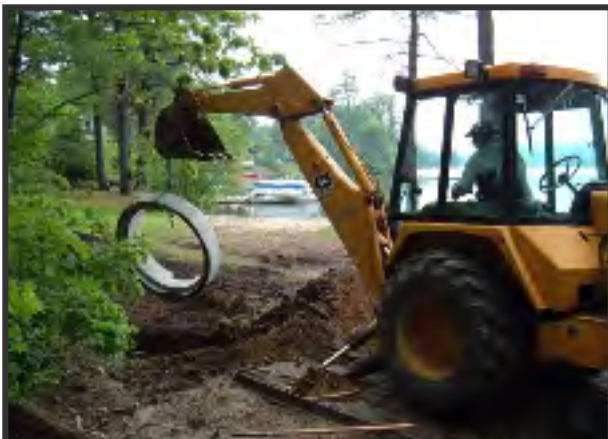
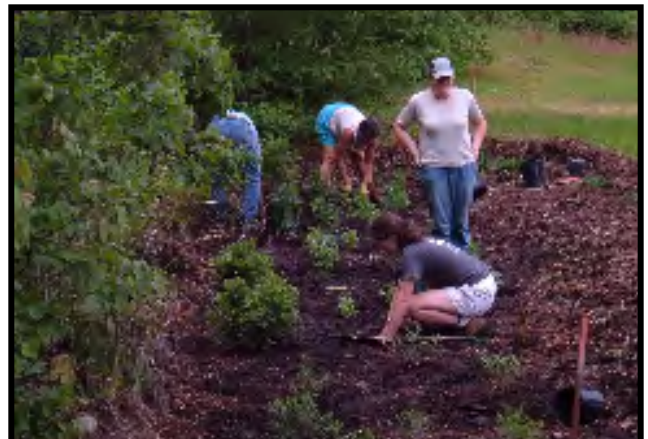
DURING: Landowner places sediment ring in rain garden, volunteers installing plants

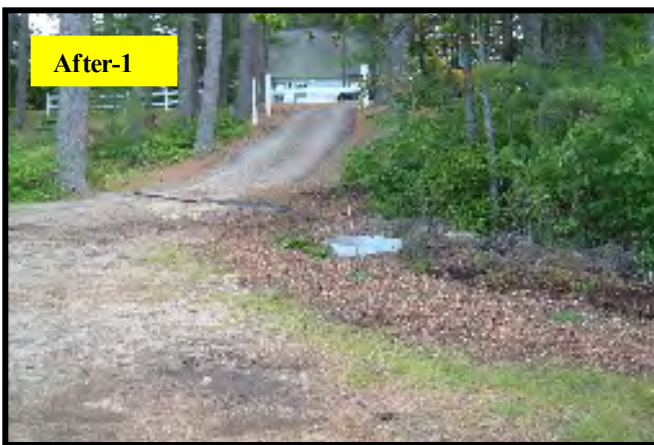
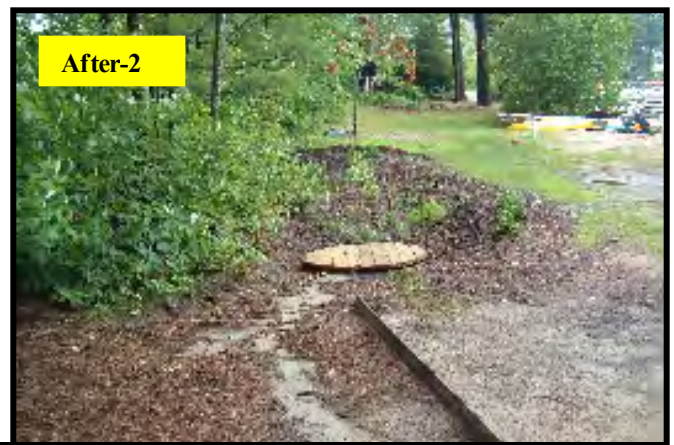
AFTER: Rubber blade diverts water from road and boat launch into the rain garden. Sediment ring catches sediment before it reaches the garden.

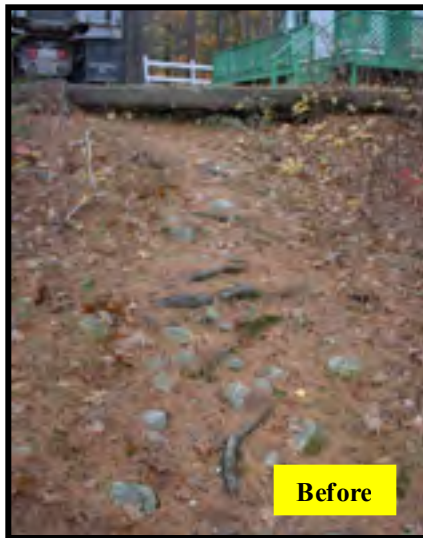
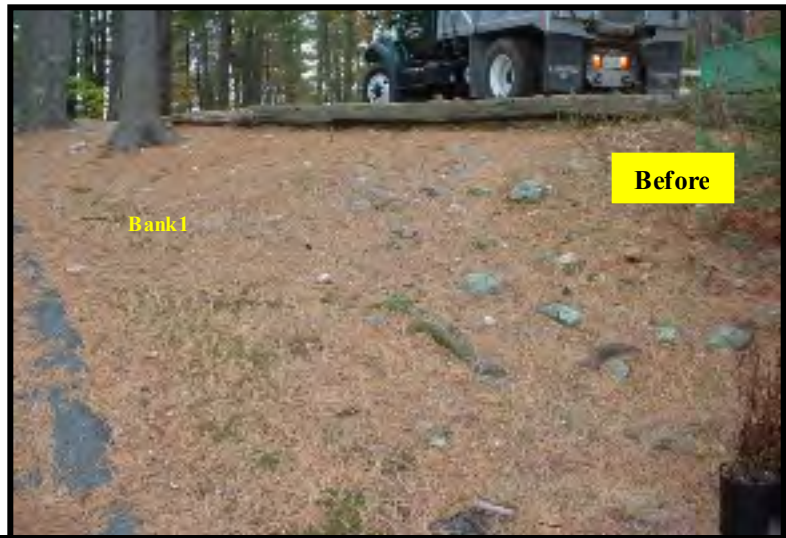
BEFORE: Stormwater runoff from road, launch and parking area erode steep bank

Plant 20'x25' vegetated buffer on bank next to boat launch, below parking area

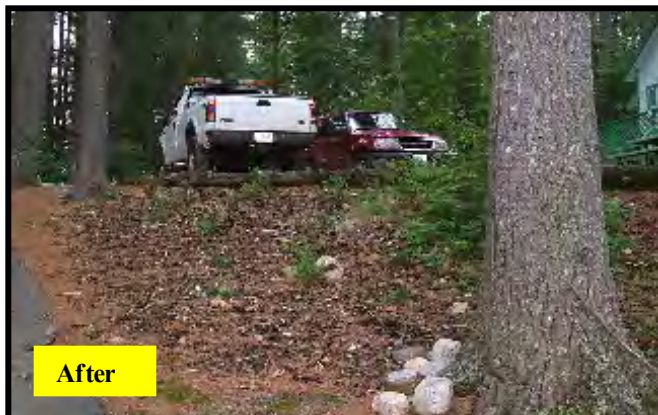
AFTER: EC mulch and vegetation stabilize eroded bank - 20' x20' vegetative buffer established

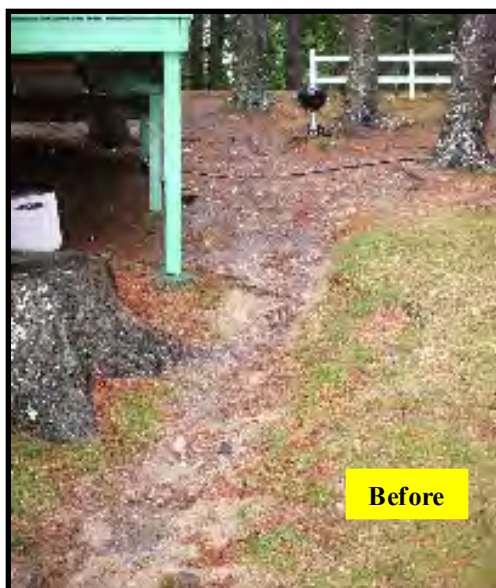
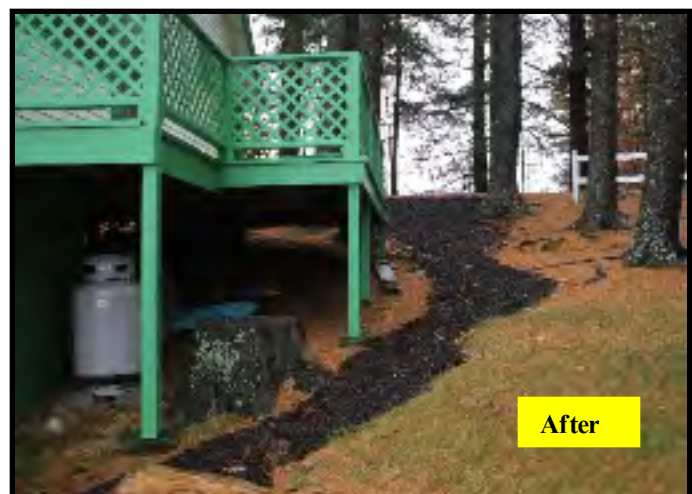
Path 3

Stabilize path with EC mulch. Camp road at top of path re-graded to shed away from path.

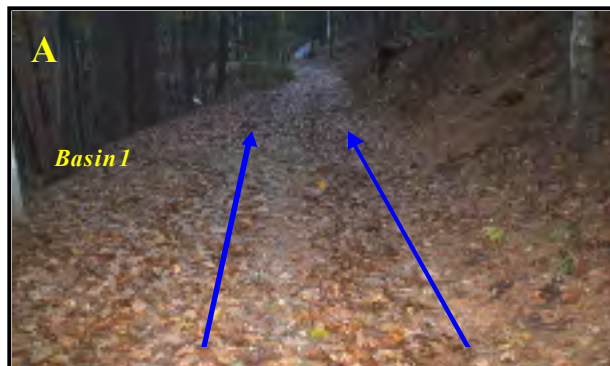
8 A

BEFORE: Large volume of storm runoff washes out camp road, camp paths, bank, and boat launch

Camp Road: Add hard packing material, grade road away from lake; install turnouts & 3 settling basins

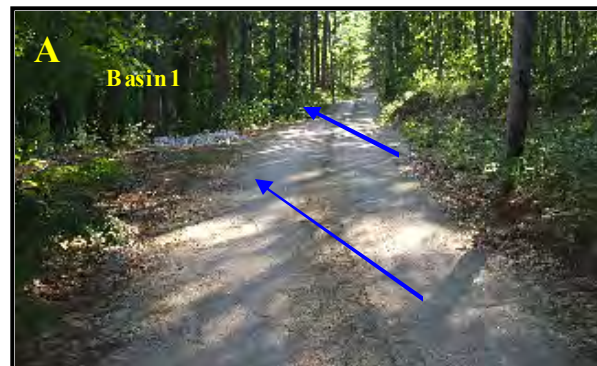
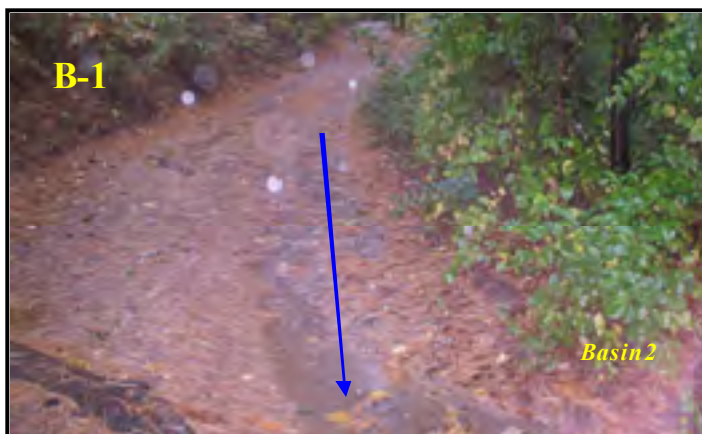
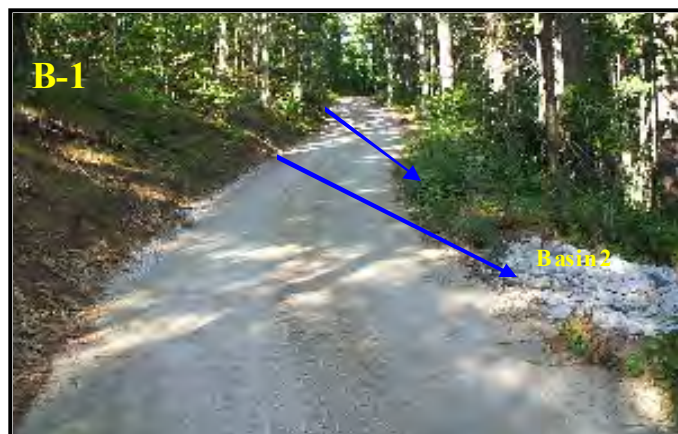
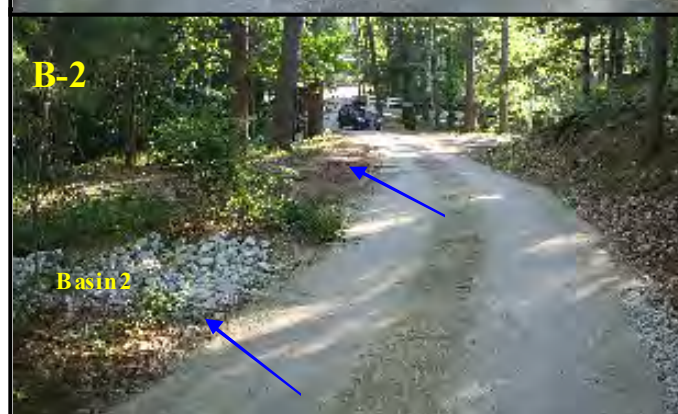
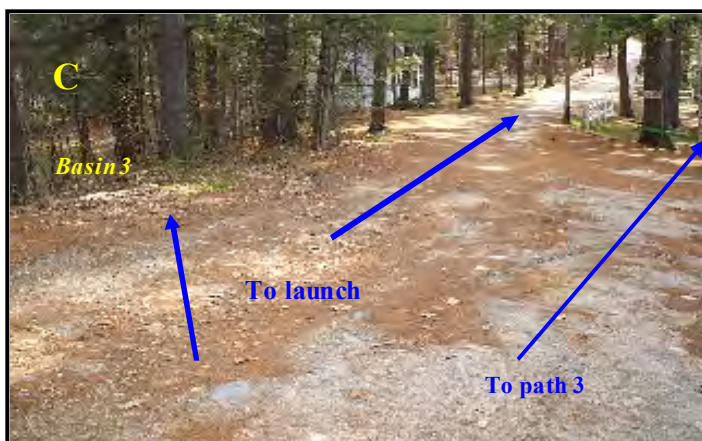
AFTER: Road crowned away from lake, path, & launch, water directed toward 3 settling basins

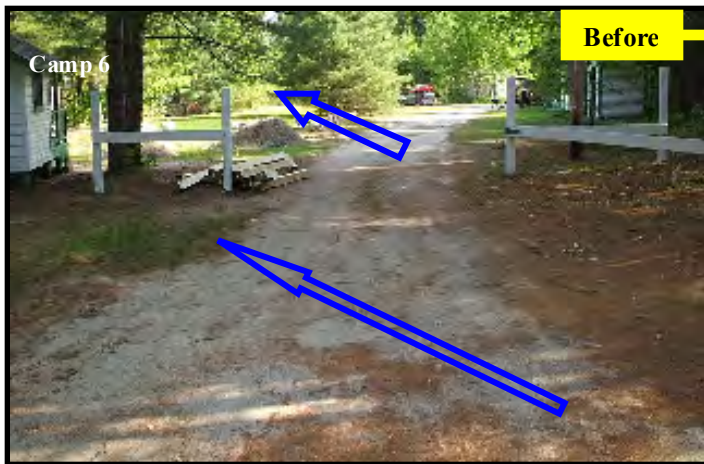
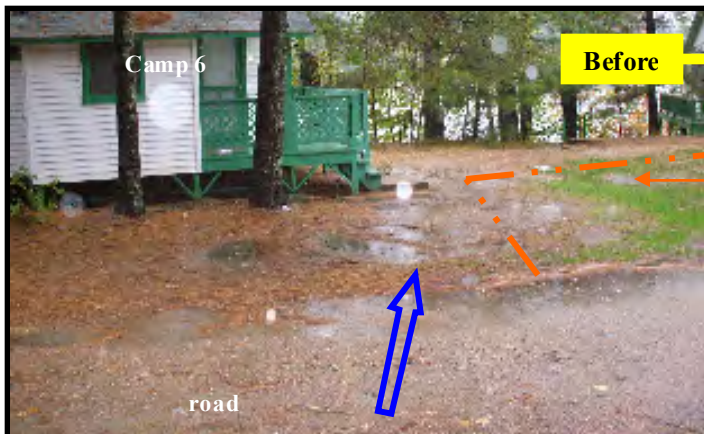
8 B

BEFORE: Stormwater runoff from camp road washes toward lake. Erodes open area and bank

BEFORE: Runoff from road causes erosion on open area, path, and bank (photos - page 15, 16)

BEFORE: Camp road washes toward paths / lake

Camp Road: Add hard packing material, grade road away from lake, install swale & settling basin

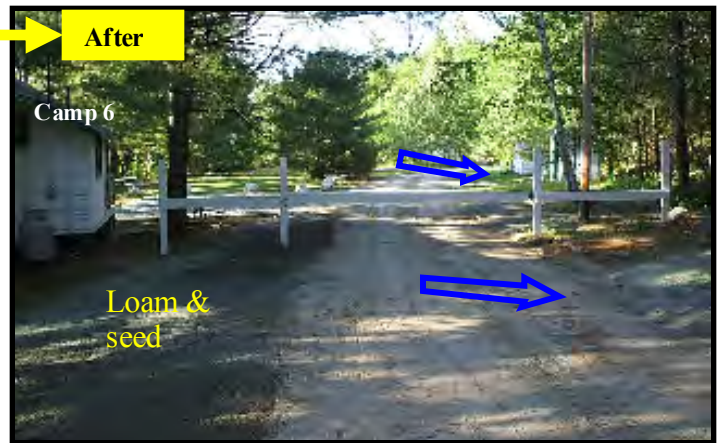
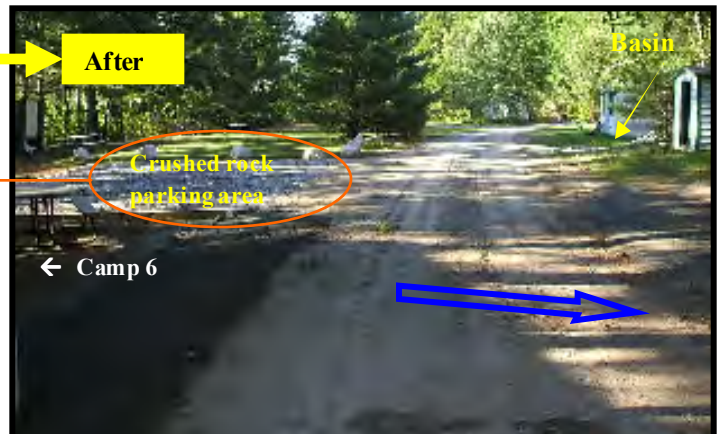
AFTER: Mono-crown road away from lake toward grass swale and settling basin, loam and seed new shoulder on lake side

AFTER: crown road to shed away from lake, loam and seed road edge & swale, define parking

AFTER: Mono-crown road to direct runoff away from lake into grass swale and settling basin

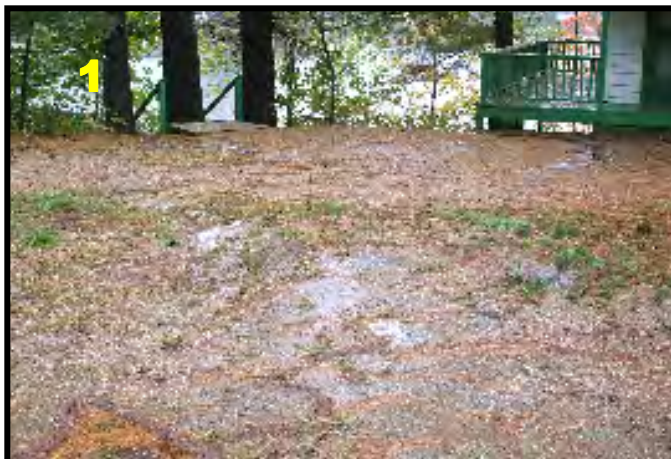
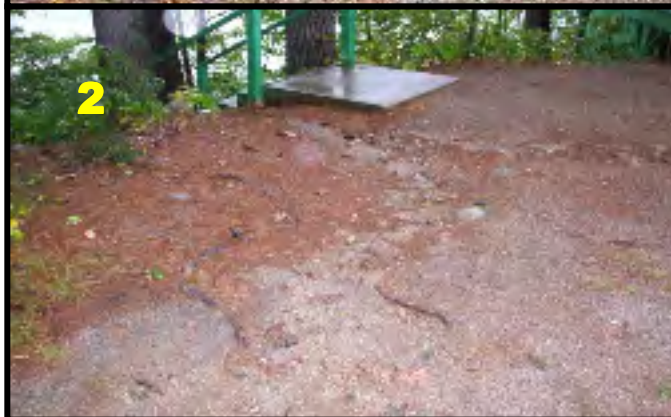
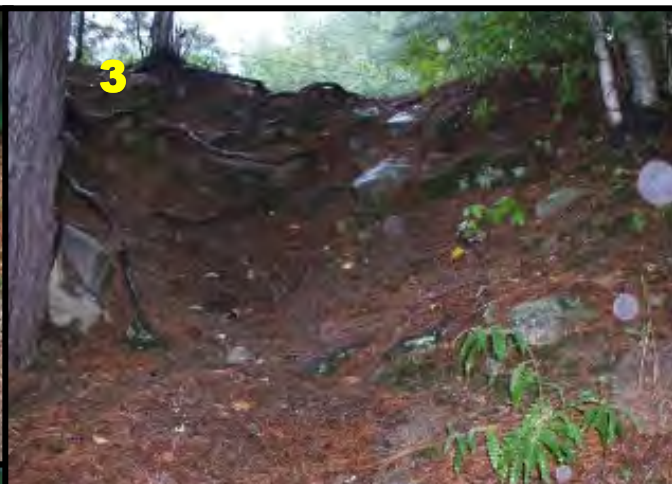
9

Bare Soil Open Area (left photos)
Eroded Bank (top photo)

Stormwater runoff from camp road and parking area erode bare soil undefined open area (1, 2).

Runoff concentrates and causes erosion across open area and severe erosion on steep bank (3)

Install 25'x40" Buffer, Define Path & Parking Area, & Stabilize Bank Erosion w/ EC Mulch

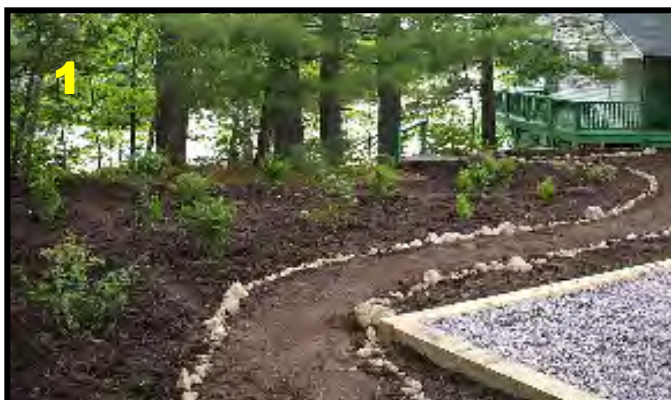
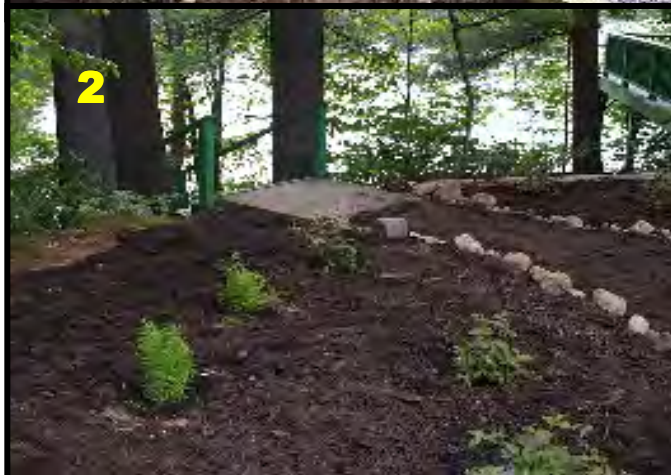
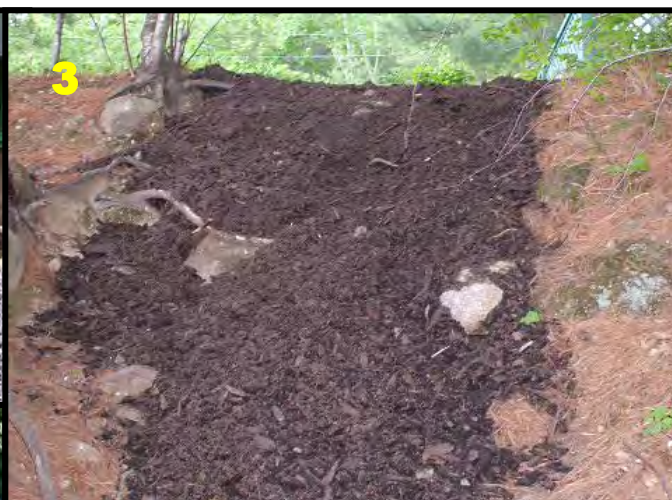
Vegetated Buffer – planted vegetation to establish 25' buffer at top of bank (1, 2)

Open Area Stabilized – defined path & parking area. Covered bare soil with EC mulch, created infiltration area for runoff in 20' x40' parking area with crushed rock (1, 2)

Stabilized Bank – steep eroded bank stabilized with EC mulch (3)

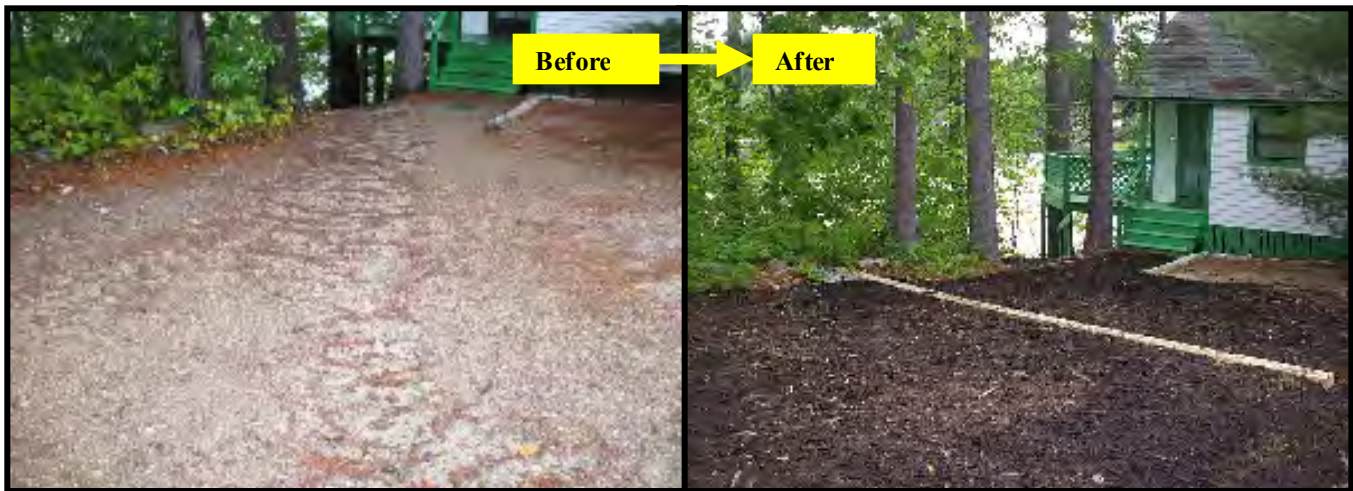
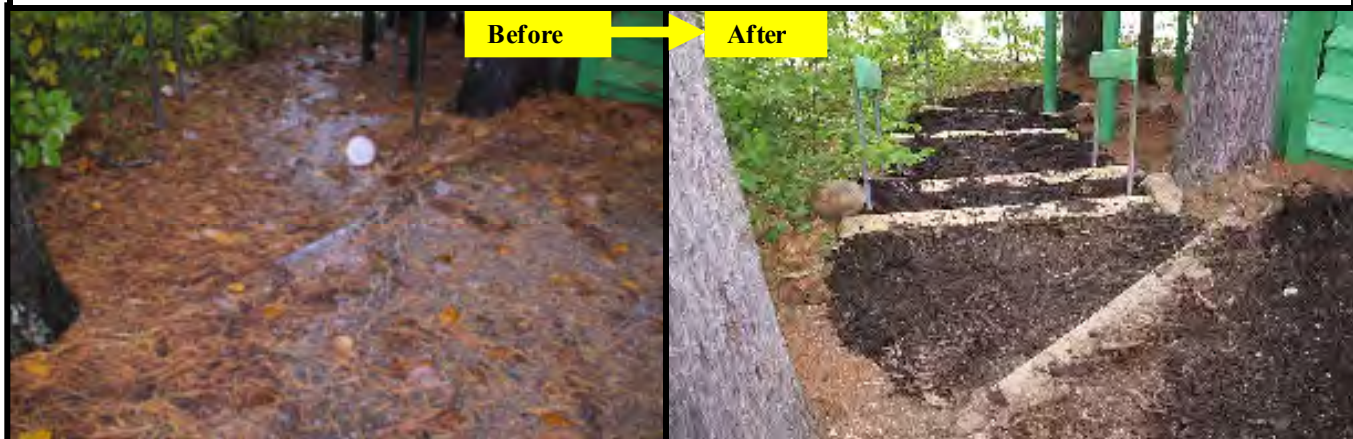
Camp Path #5

BEFORE: Runoff from open area (top photo) washes out camp path (bottom photo) directly to lake

AFTER: Water diverter (timber) directs water into vegetation and away from path, EC mulch covers and stabilizes bare soil (top right photo). Infiltration steps (timbers with crushed rock behind) installed on bank path, EC mulch stabilizes the path (bottom right photo).

Camp Road Runoff Washes out Open Area & Path → EC Mulch and Infiltration Steps Installed
